SCALED-UP SANITATION SOCIAL AUDIT

CITY OF EKURHULENI - 2018

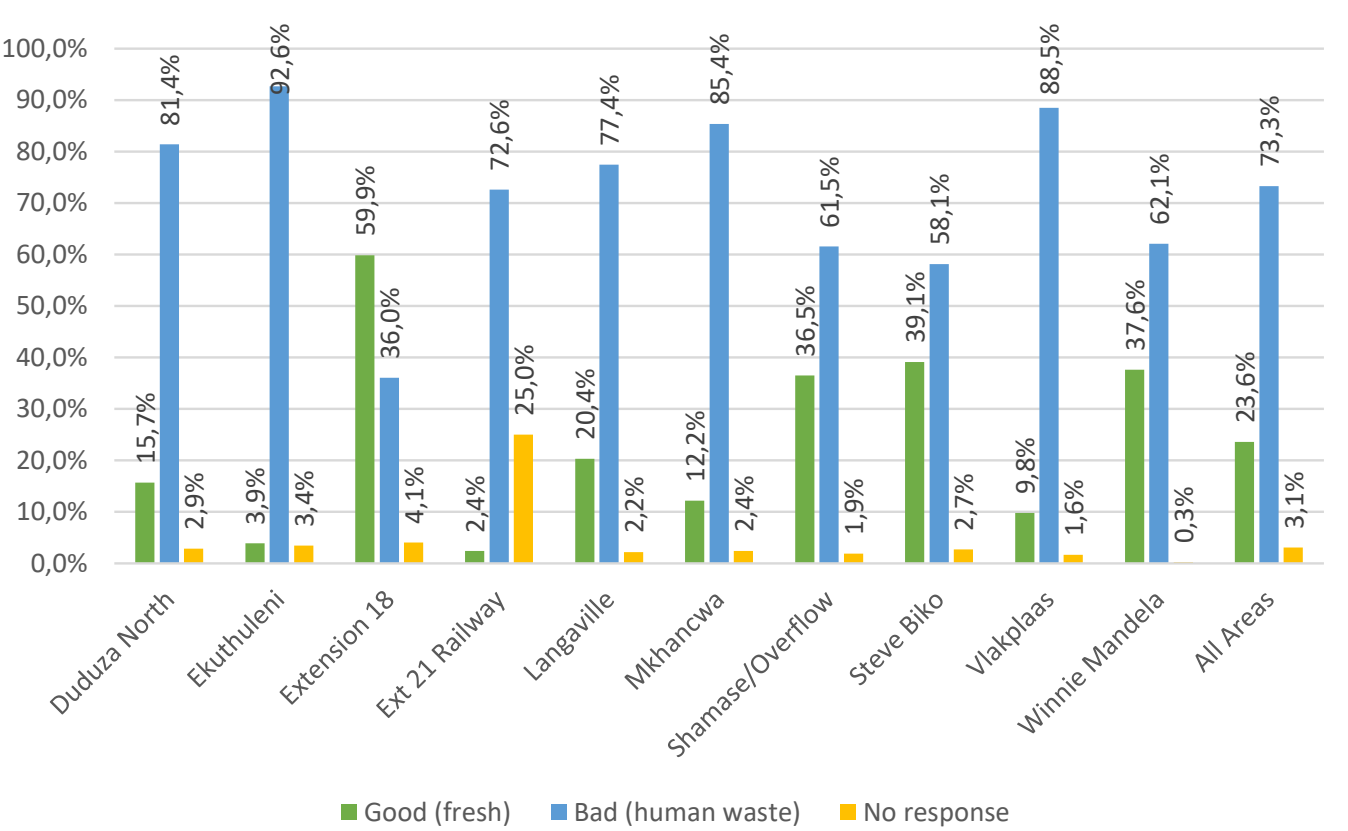
Figure 3: How does the toilet smell inside?

As part of the physical verification of the portable toilets, the social auditors were asked to indicate how the toilet smells inside: “Good (fresh)” vs “Bad (human waste)”. Figure 3 shows that less than a quarter of auditors indicated that the toilet they inspected smells good (fresh) inside. These findings also varied significantly across settlements. In Extension 18, a relatively high proportion of almost 60% of auditors indicated that the toilet smells good inside. In Ekuthuleni, on the other hand, fewer than 4% of auditors commented positively on the smell inside the toilet. In Extension 21 Railway, fewer than 3% of

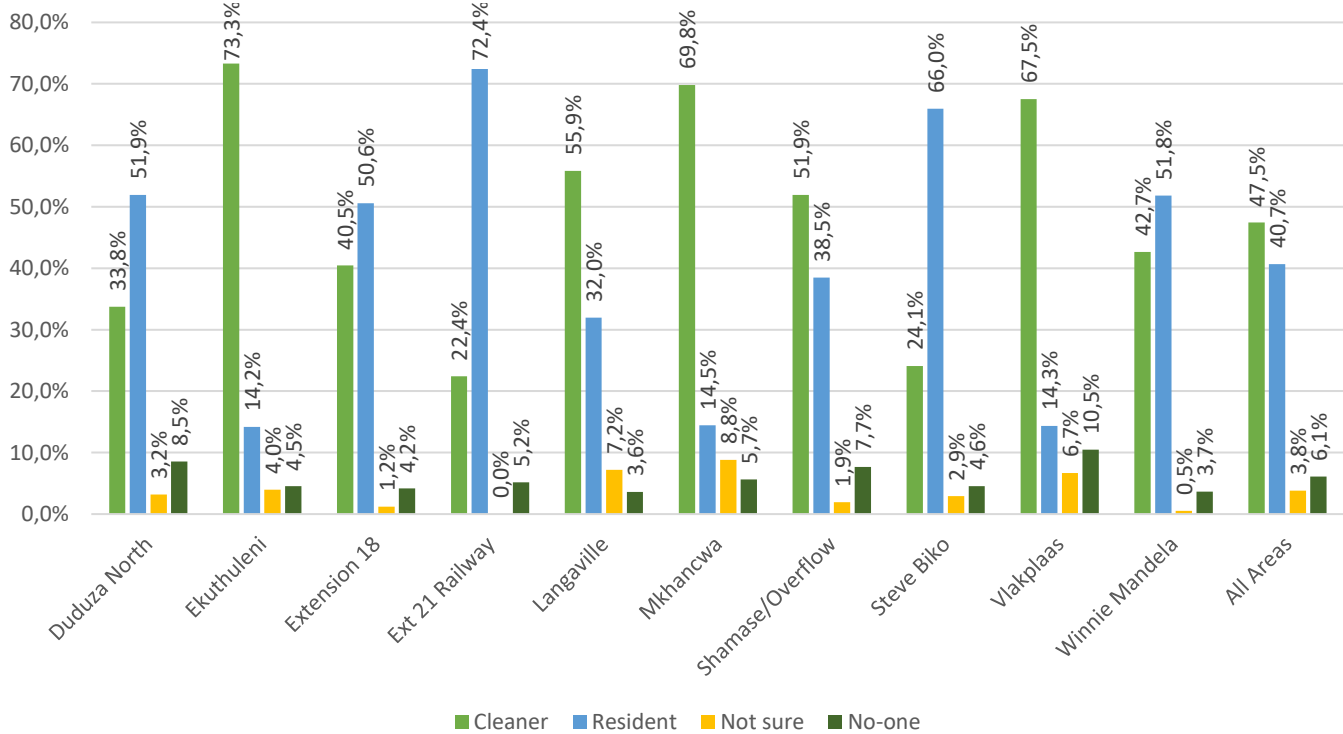
Figure 4: Who cleans the toilet?

As can be seen in Figure 4 below, the responses varied significantly across the ten informal settlements. On average, about half of all residents said that a cleaner cleans the toilet, which we take to mean a cleaner employed by the relevant contractor.

In Ekuthuleni, Mkhancwa and Vlakplaas, around 70% of residents said that a cleaner cleans the portable toilet, while in all three areas about 14% indicated that a resident cleans the toilet. In contrast only 22.4% and 24.1% of respondents in Extension 2 Railway and Steve Biko respectively, indicated that a cleaner cleans the toilet with the majority saying this is done by a resident. For the other areas, between 34.5% and 56% of respondents indicated that their toilets are cleaned by a cleaner. In Duduza North and Vlakplaas relatively high shares of 8.5% and 10.5% respectively, indicated that no-one cleans the toilet.

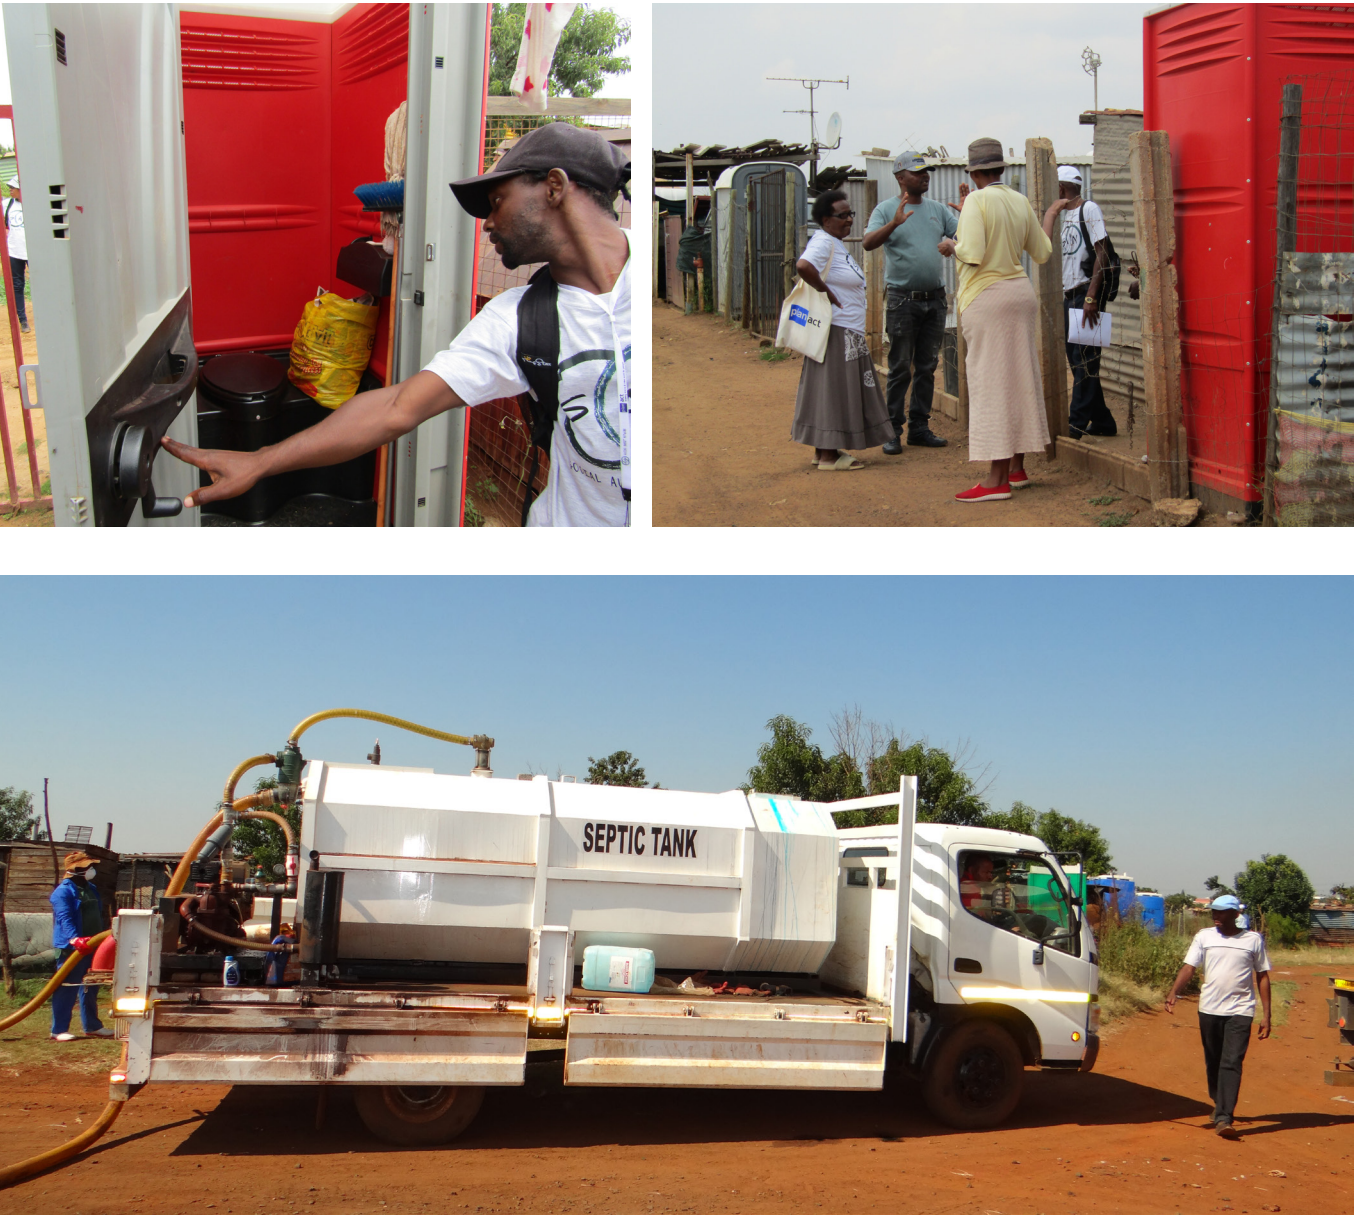
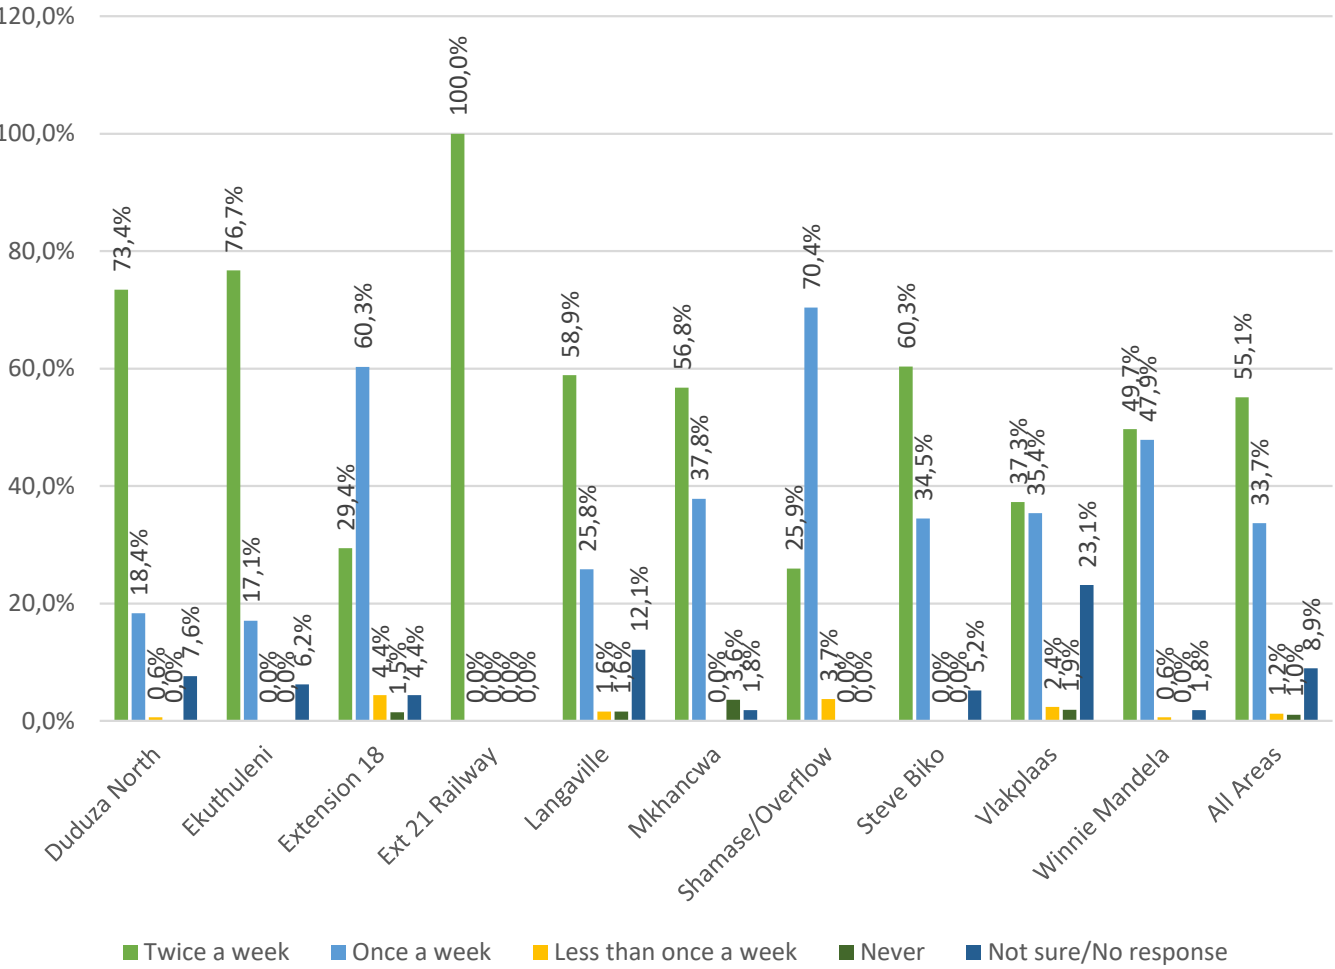
Figure 5: How many times a week is the toilet cleaned (by cleaner)?

Residents were asked how many times a week the portable toilet is cleaned. Figure 5 only shows the responses for those who initially indicated that the toilet is cleaned by a cleaner. Overall, more than half of respondents indicated that a cleaner cleans the toilet twice a week. The result for Extension 21 Railway stands out as the only area for which all respondents indicated that the

set of findings in Figure 4 showed that at 73.3% the highest relative share of respondents that indicated that the toilet is cleaned by a cleaner, lives in Ekuthuleni. Figure 5 shows that almost 77% of these residents indicated that the cleaner does this task twice a week. Together these two sets of findings suggest a comparatively high level of compliance with this specific bid specification in this settlement.

The results vary for the other areas, from 25.9% for Shamase/Overflow to 73.4% for Duduza North. The relatively good result for Duduza North should be read together with the finding in Figure 6 – that only about 34% of residents indicated that the toilet they use is being cleaned by a cleaner.

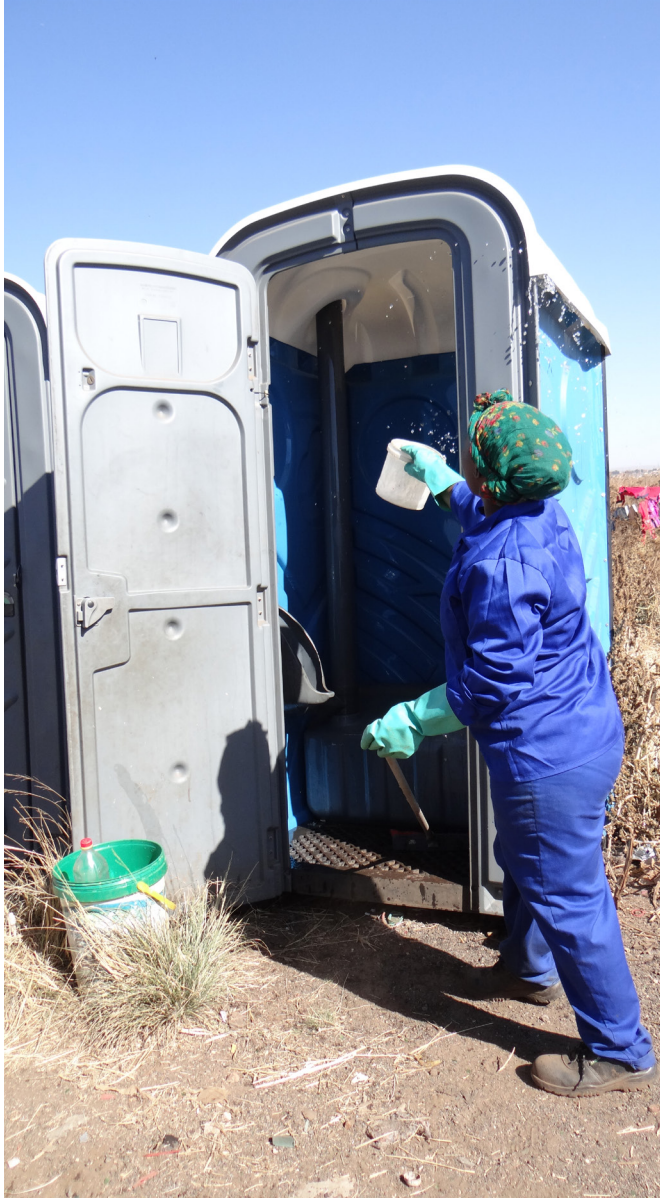
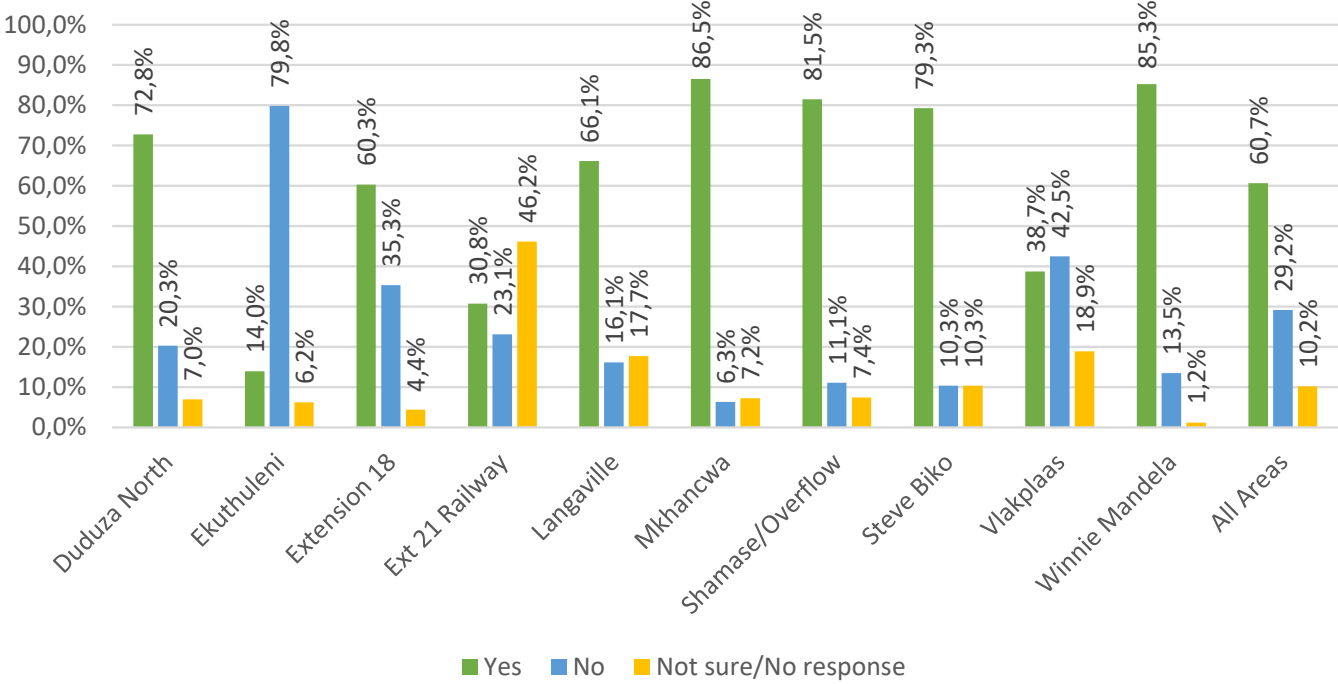
Figure 6: Is the toilet cleaned immediately (by the cleaner) after the human waste has been removed?

Residents were also asked if the toilet is cleaned immediately after the human waste has been removed by the vacuum truck. Again, Figure 6 only shows the responses for those who initially indicated that the toilet is cleaned by a cleaner. The responses vary significantly across settlements. In Steve Biko, 79.3% of respondents indicated that the toilet is cleaned immediately after the waste has been removed. But for this settlement it should again be kept in mind that only about 24% of respondents indicated that the toilet is cleaned by a cleaner. This means that a very small number of toilets are actually cleaned by a cleaner immediately after the waste has been removed.

In Mkhancwa, Shamase/Overflow and Winnie Mandela, more than 80% of respondents indicated that their toilets are cleaned immediately after the human waste has been removed. The finding for Shamase is less impressive when we consider that only a little over 50% of the portable toilets are cleaned by a cleaner. Of the toilets cleaned by a cleaner only a quarter of those toilets are cleaned twice a week as required by the bid specifications. Similarly, only about 43% of residents in Winnie

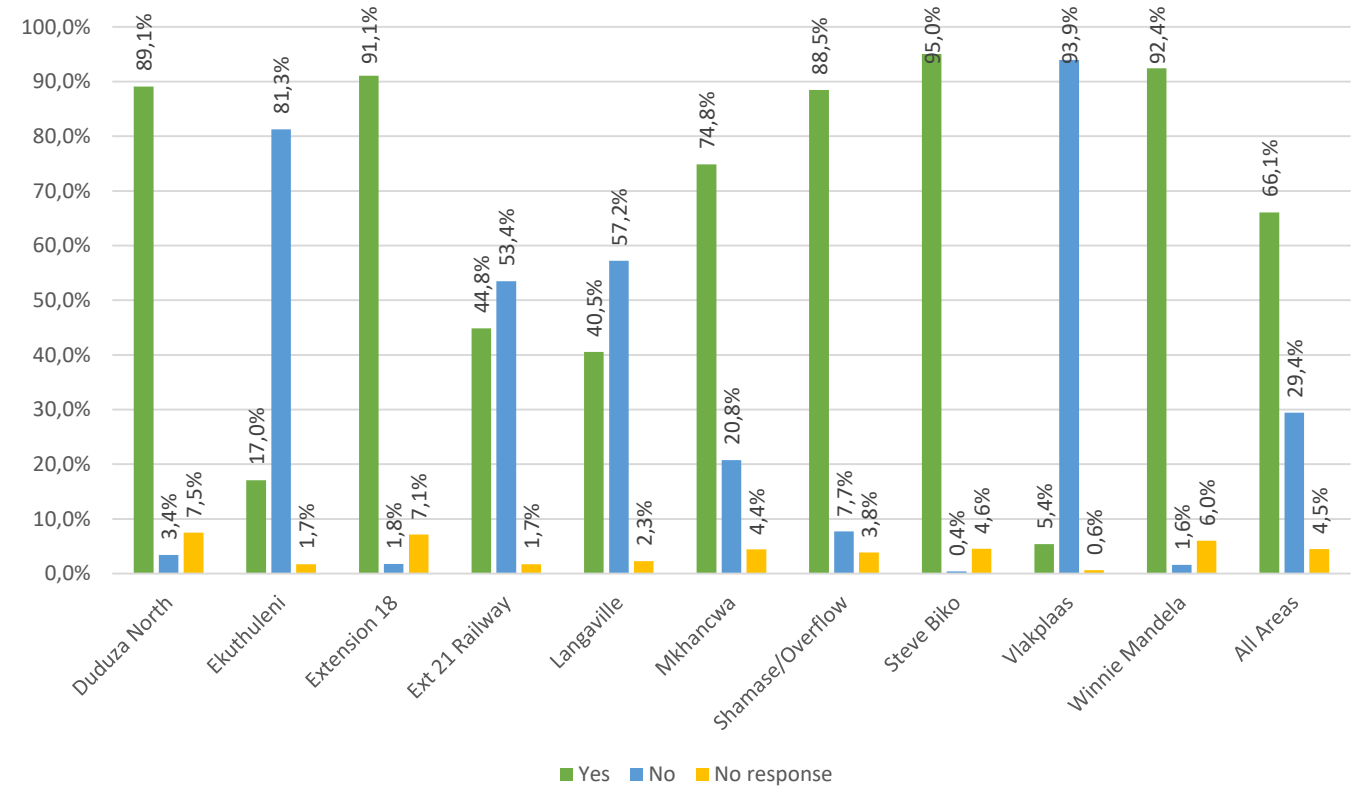
Figure 7: If you use a portable toilet, is it in your yard?

The bid specifications do not stipulate where the portable toilets should be positioned. When residents were asked whether the toilet they use is in their yard, the answers varied widely across settlements as shown in Figure 7. As mentioned before, in Vlakplaas the portable toilets have been

placed on the outskirts of the area and only 5.4% of respondents indicated that they have a portable toilet in their yard.

Between 88.5% and 95% of respondents living in Duduza North, Extension 18, Shamase/Overflow, Steve Biko and Winnie Mandela indicated that the toilet is in their yard. These five settlements also have the highest shares of one family per portable toilet. In contrast, only 17% of respondents living in Ekuthuleni indicated that the toilet is in their yard. This settlement has a relatively large share of more than one family sharing a toilet.

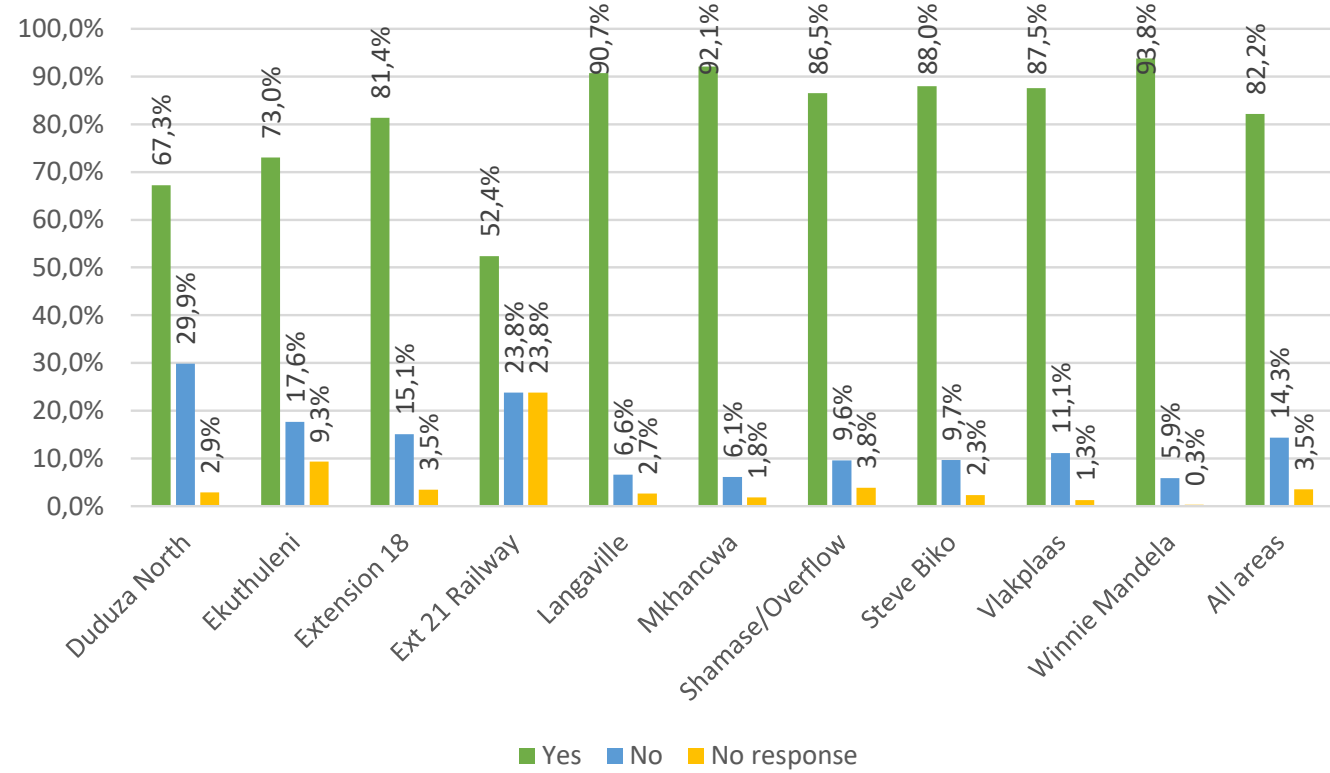
Figure 8: Is the toilet accessible by the vacuum truck?

8 show that social auditors found that more than 82% of the 2 289 toilets inspected are accessible by the vacuum truck. There is some variation across settlements. In Duduza North, auditors indicated that only 67.3% of portable toilets inspected are accessible by vacuum truck. In Winnie Mandela, the auditors found that almost 94% of toilets verified can be accessed by the vacuum truck. (The results for Extension 21 Railway are skewed by the relatively large share of “No response” answers to the question.)

- > re-positioning of toilets where necessary to ensure access by a vacuum truck;
- > stabilising of toilets where necessary; and
- > rectification of all toilets to ensure that they conform to the bid specifications
- > The findings of the needs assessment should inform improved bid specifications in the new contract for the delivery and servicing of chemical toilets in informal

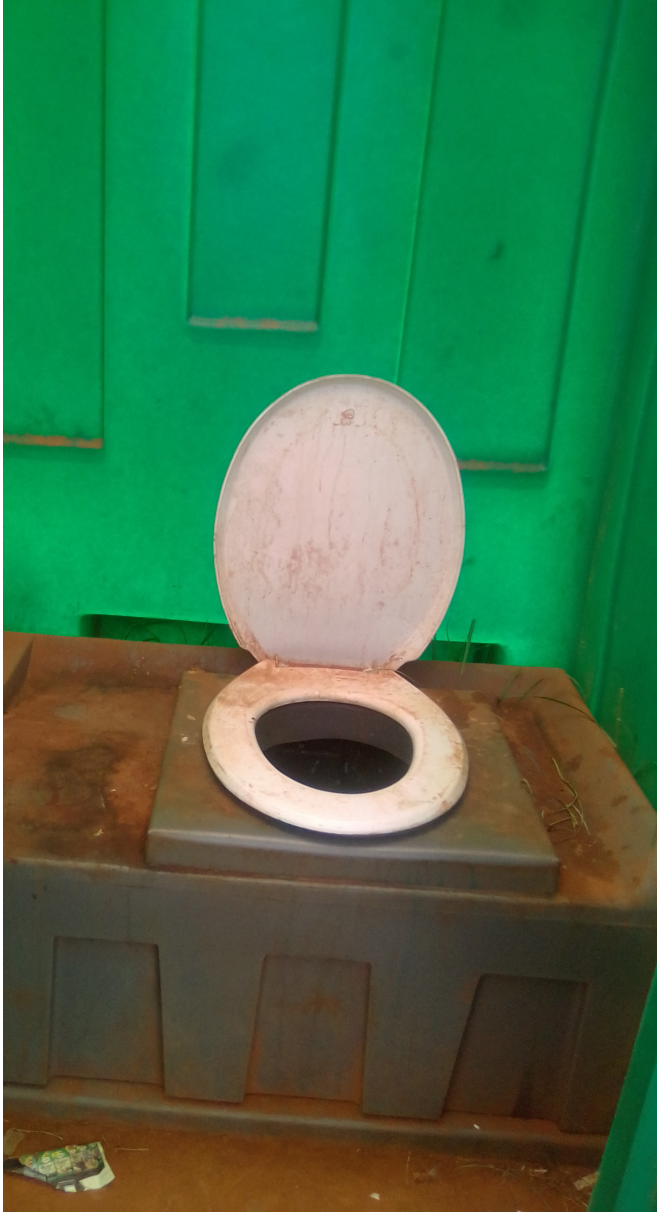
Figure 9: Toilet number observed

For only 1 056 of the 2 289 toilets verified, or 46.1%, did the social auditors indicate that a toilet number (unique identification number) can be observed. Figure 9 shows that the results vary significantly across settlements. For example, almost 87% of the toilets inspected in Langaville have a toilet number, while only 2.6% of the toilets inspected in Steve Biko have toilet numbers. Lack of a unique identification number makes it more

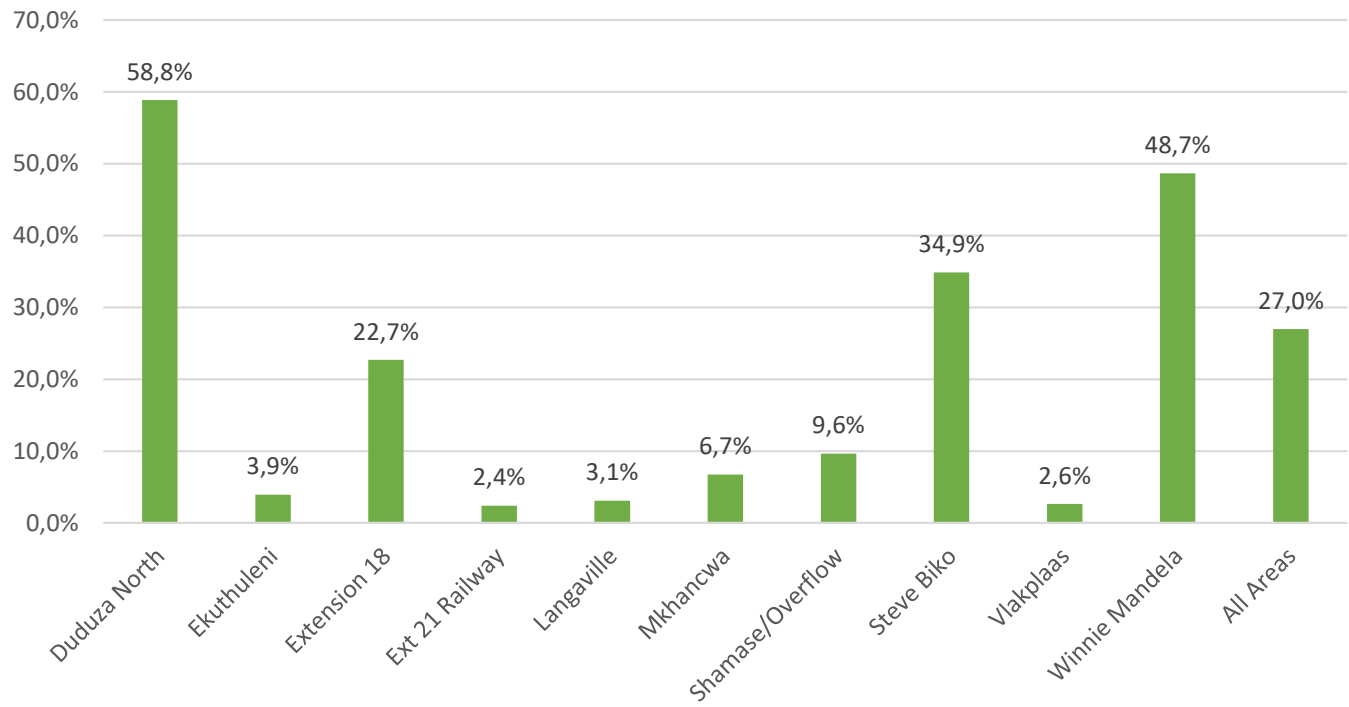
Figure 10: Call centre number observed

Figure 10 shows that at 27%, an even smaller share of the portable toilets inspected has the call centre number visible on the outside of the toilet unit. Again, the shares vary across settlements, with almost 59% of the units inspected in Duduzu

This finding points to a more serious problem. If there is no call centre number on the toilet unit, residents will probably not know which number to call or who to call when there are problems with the toilets or the delivery of the service.

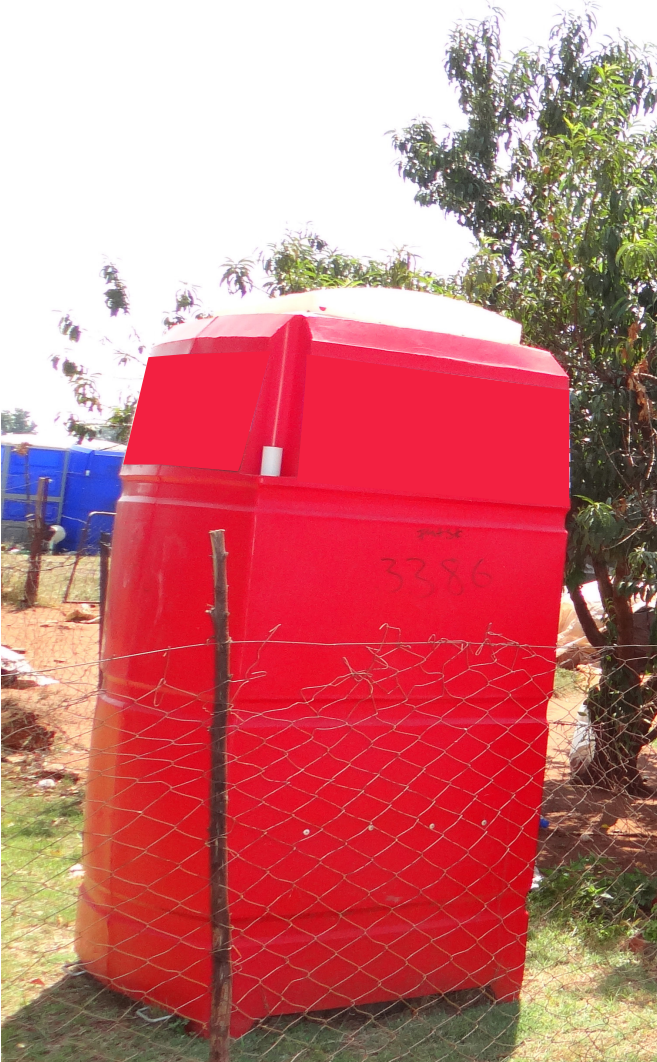
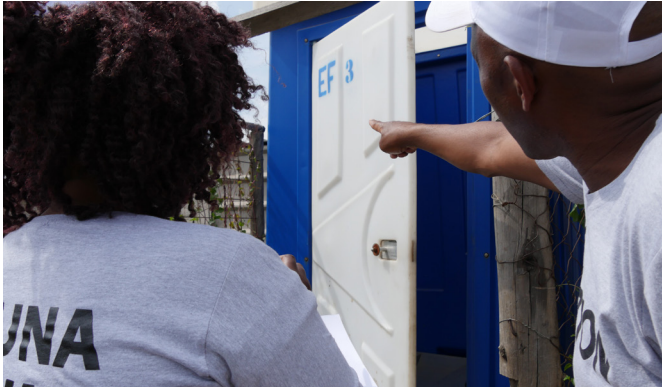
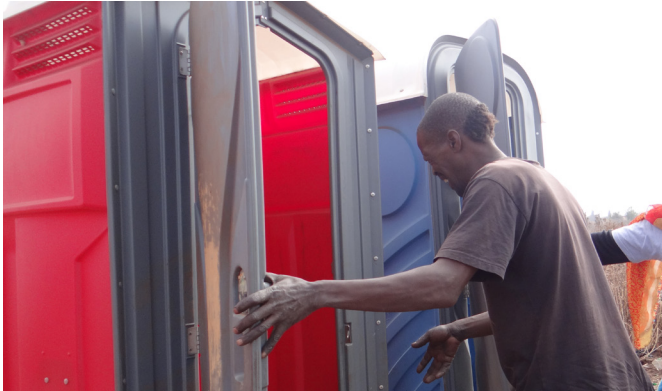
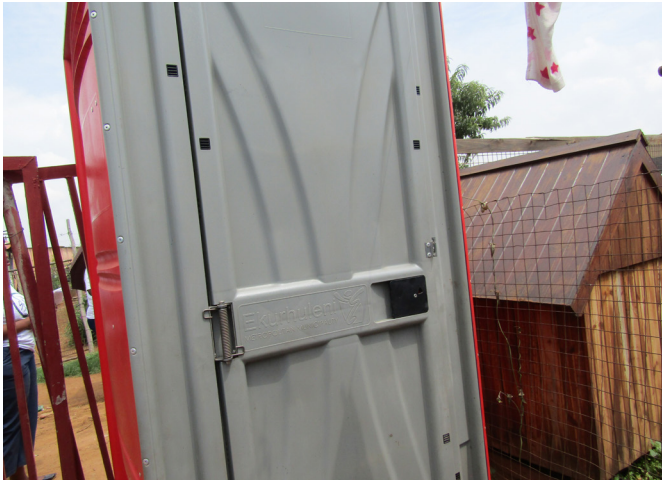
Figure 11: Observations about the door of the toilet unit

Figure 11 presents a summary of the findings from the inspections of the doors of the portable toilet units.

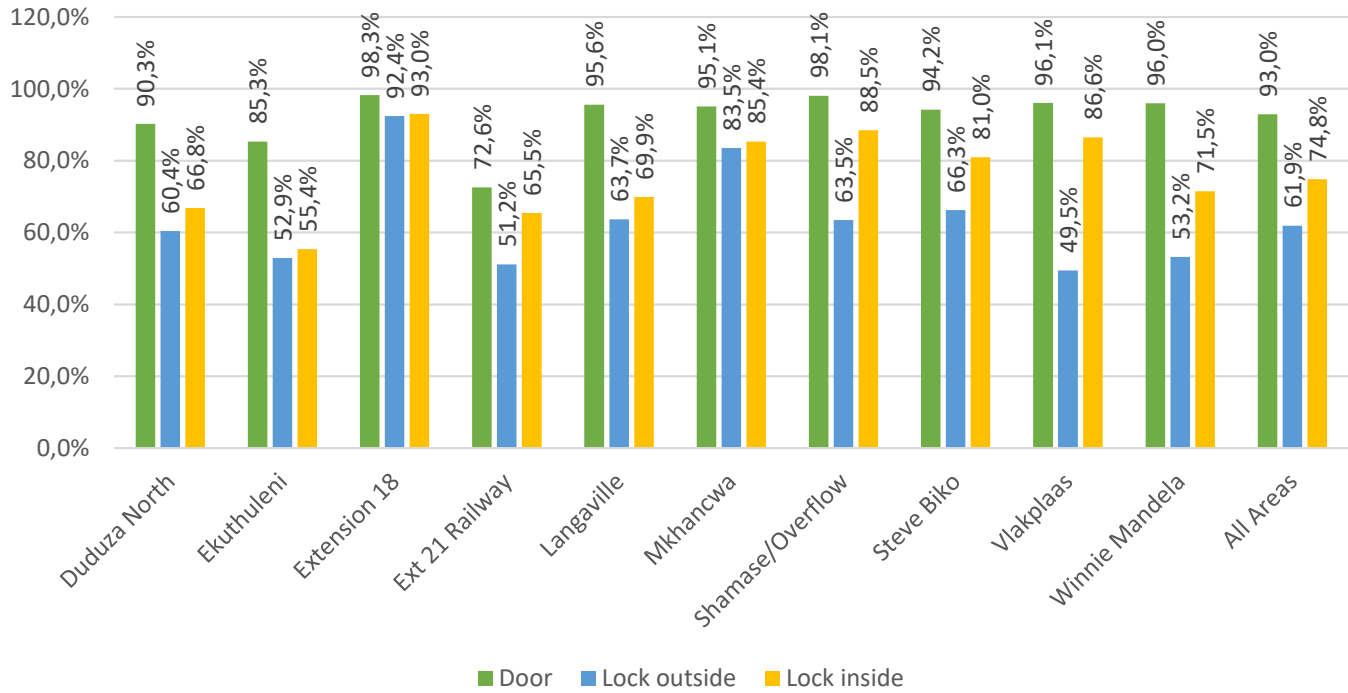
In the other eight areas, the shares of the toilet doors that can lock from the outside varied significantly from fewer than 50% in Vlakplaas to

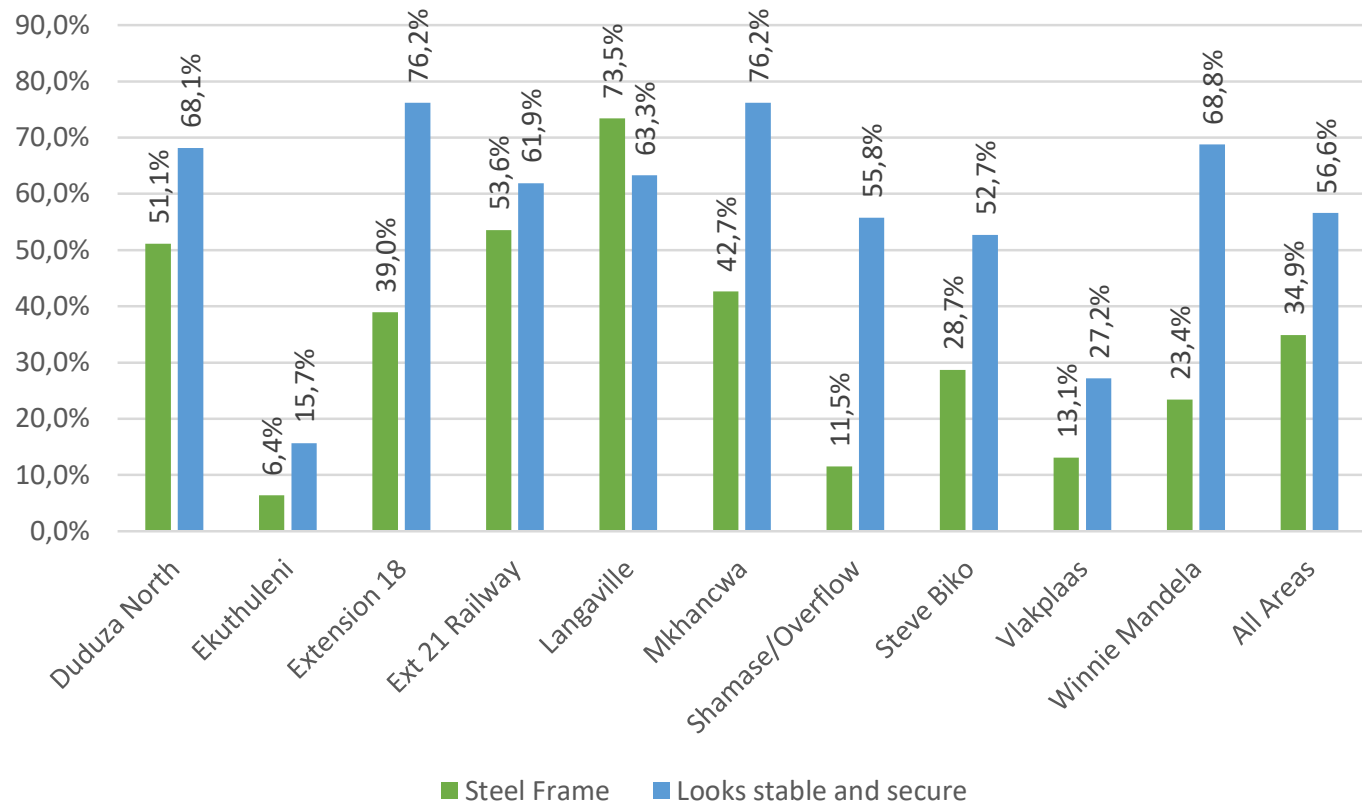
Figure 12: Stability of the toilet structure

In addition to the obvious violation of the contract specifications in all settlements, for eight of the ten settlements, only between half and three-quarters of structures were found by the social auditors to look stable and secure. The two clear outliers are Ekuthuleni where only 15.7% of the toilet units look stable and secure, and Vlakplaas where 27.2% of the toilet units appear stable and secure.

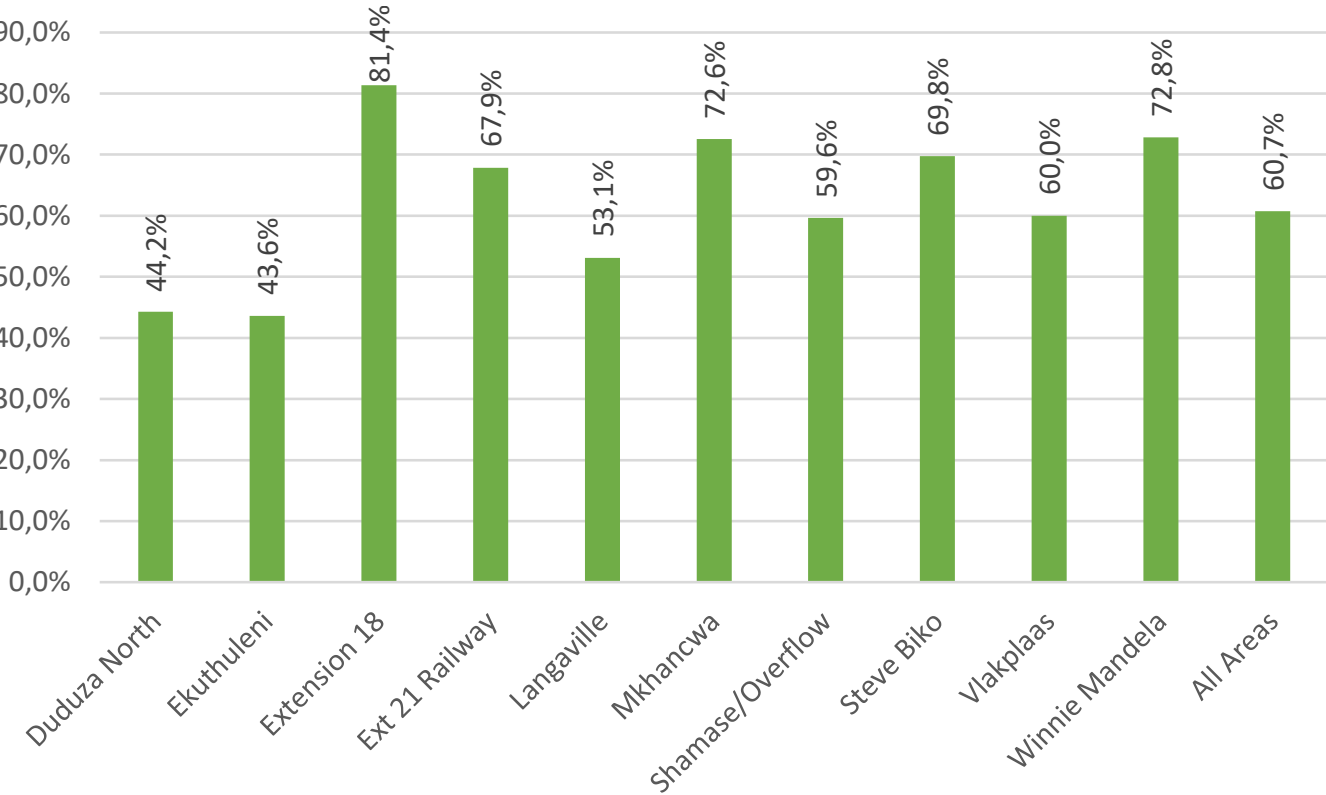
Figure 13: Is the toilet well ventilated?

The social auditors found that only just more than 60% of all toilets are well ventilated. The shares by area again point to large variations across settlements. In Extension 18 more than 80% of toilets inspected were found to be well ventilated. In contrast, only 43.6% of toilets verified in

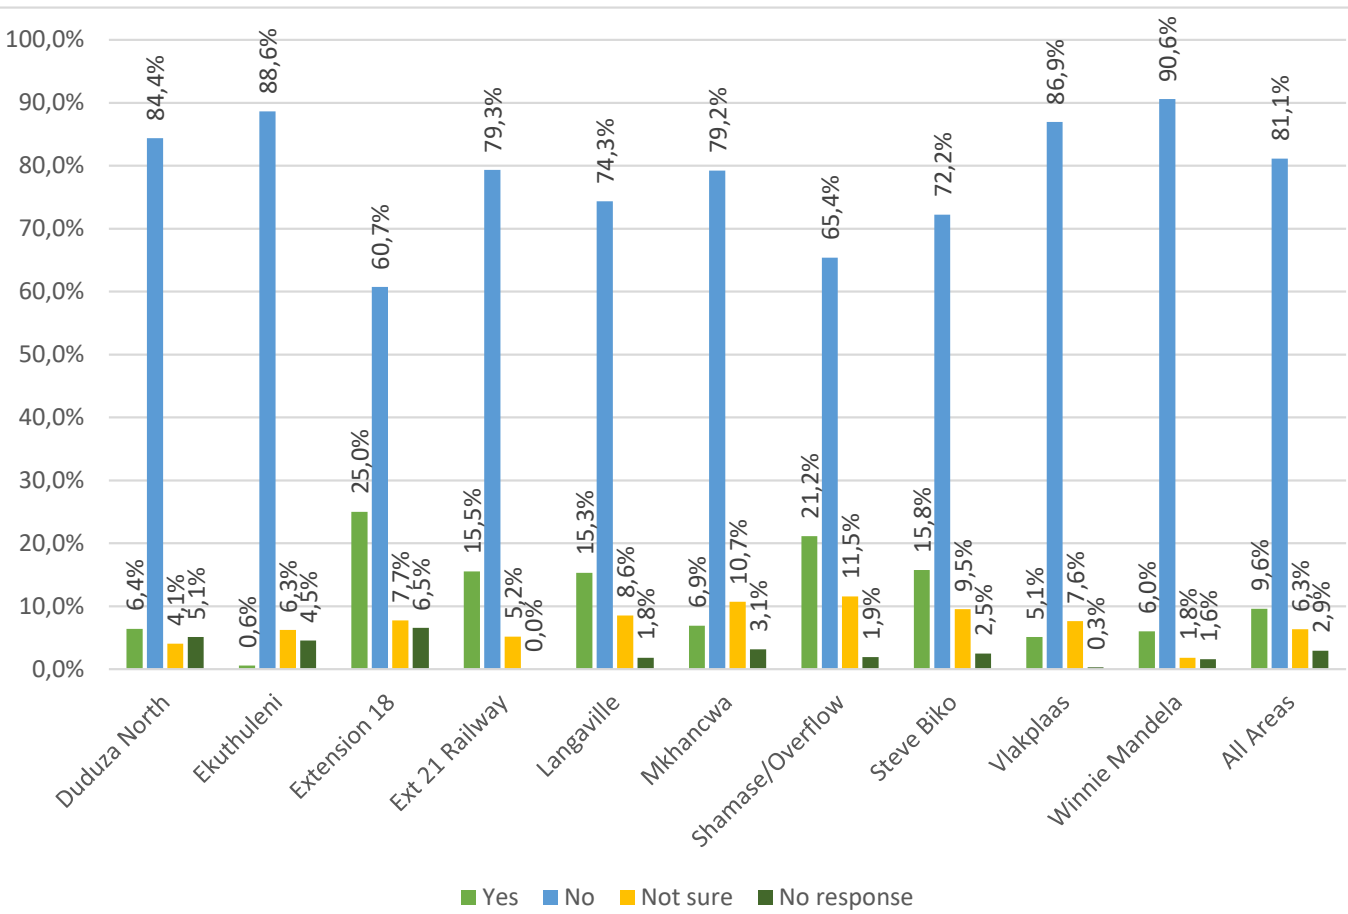
Figure 14: Does somebody monitor if the toilet is being cleaned and the human waste is being removed properly?

Residents were asked if somebody monitors if the toilet is being cleaned and the human waste is being removed properly. Figure 14 shows that on average less than 10% of respondents answered yes to this question. More than 80% of respondents answered no, while 6.3% said that they were not sure. It should be noted that the residents were not asked specifically whether an official from the municipality monitors the delivery of the services.

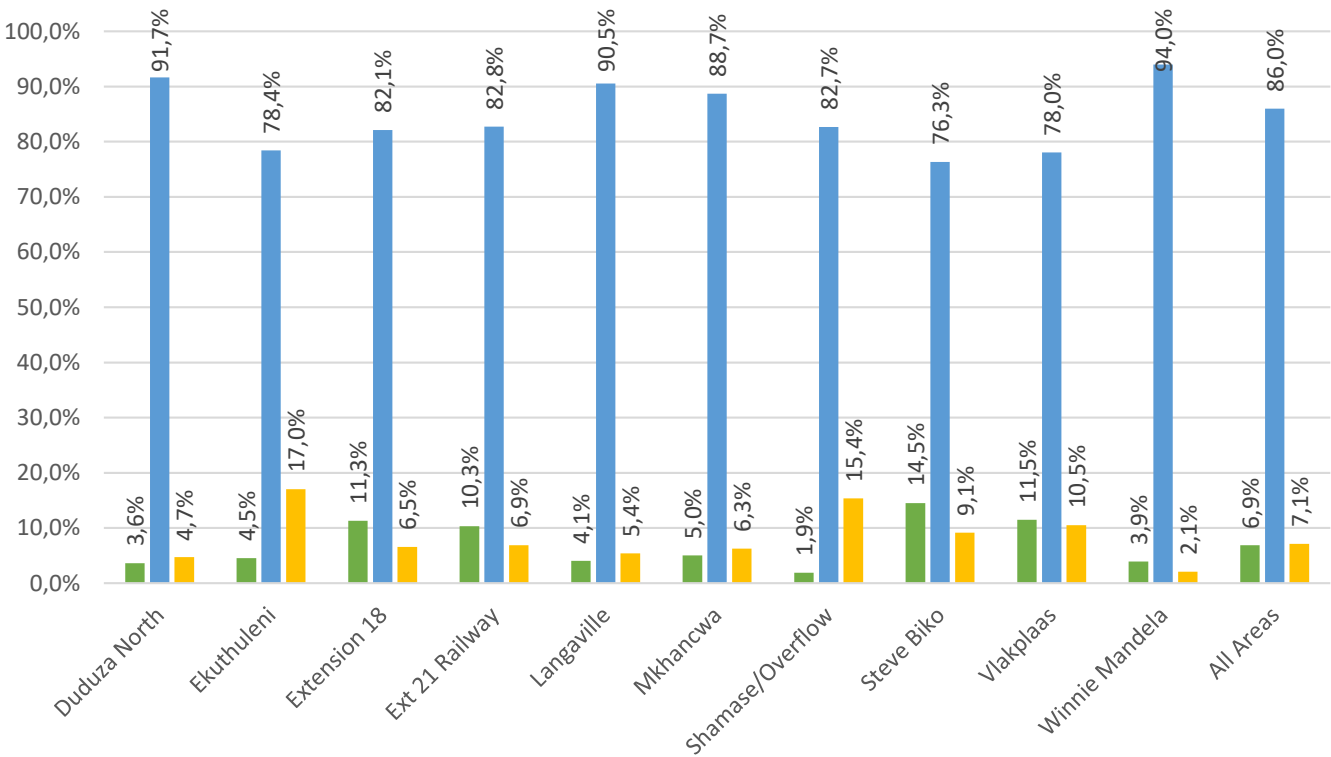
Figure 15: Is a disabled person able to use the portable toilet?

While the bid specifications list a number of requirements specifically related to the structure of the portable toilet unit, no explicit mention is made of accessibility for people with disabilities. When residents were asked if a disabled person is able to use the toilet, only 6.9% said “Yes”.

The findings from the physical verification of the portable toilets generally confirm the findings above. Only 5.7% of the social auditors found that the toilet they inspected is suitable for people with disabilities. The social auditors observed whether there are rails for people to hold on to for support, as well as whether there is a ramp for a wheelchair and toilet unit is big enough to allow access by a wheelchair.

- > Provision for the delivery and maintenance of toilets that are accessible to disabled

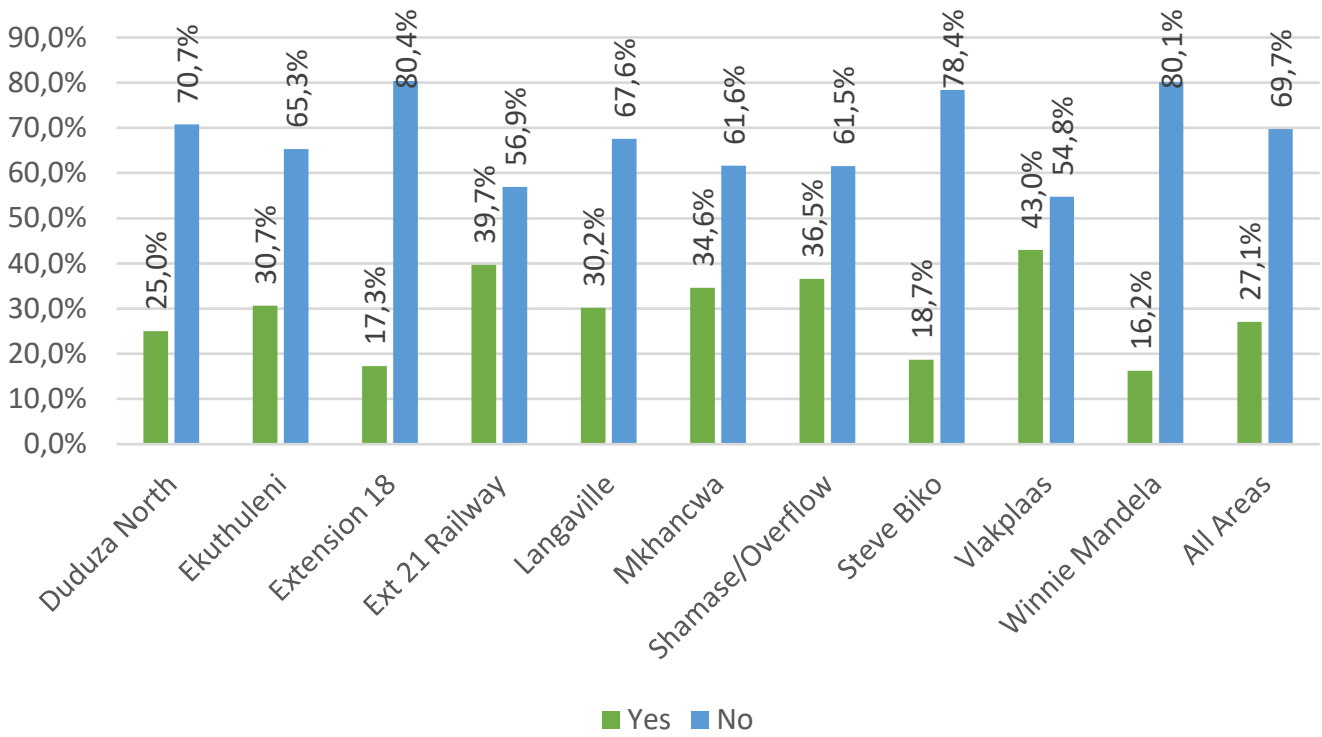
Figure 17: Have you ever had any health problems from using the toilet?

More than a quarter of residents who indicated that they use a portable toilet, said that they had experienced health problems from using the toilet. Figure 17 shows how the responses vary across informal settlements. The share of respondents who indicated health problems was relatively higher than the average in Ekuthuleni (30.7%), Extension 21 Railway (39.7%), Langaville (30.2%), Mkhancwa (34.6%), Shamase/Overflow (36.5%) and Vlakplaas (43%).

Seventeen of the community members interviewed using the Community Member Questionnaire said that they have experienced health problems as a result of using the portable toilet. Many specifically indicated that they have

trouble breathing as a result of the strength of the chemicals. Some community members questioned whether the chemicals used were safe or approved, as per the bid specifications. Another community member said that he/she got a rash from using the portable toilet.

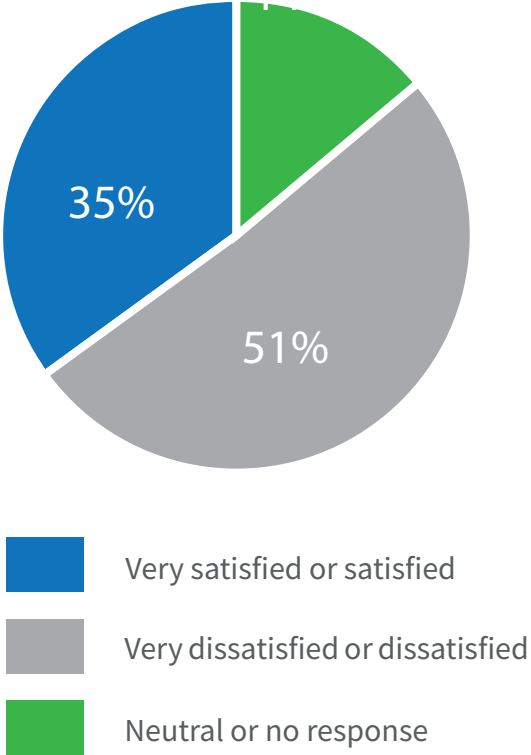
Figure 18: How satisfied are you with the sanitation services provided? (community members)

The community members interviewed separately, using the Community Members Questionnaire, were asked to rate their level of satisfaction with the sanitation services provided by the municipality/service provider. Figure 18 shows the summary of the responses by the 57 residents who indicated that their household has access to a portable toilet.

More than half indicated that they are either dissatisfied or very dissatisfied with the service while just 35% indicated that they are either satisfied or very satisfied. The remainder were neutral or did not answer the question.
