SCALED-UP SANITATION SOCIAL AUDIT

CITY OF EKURHULENI - 2018

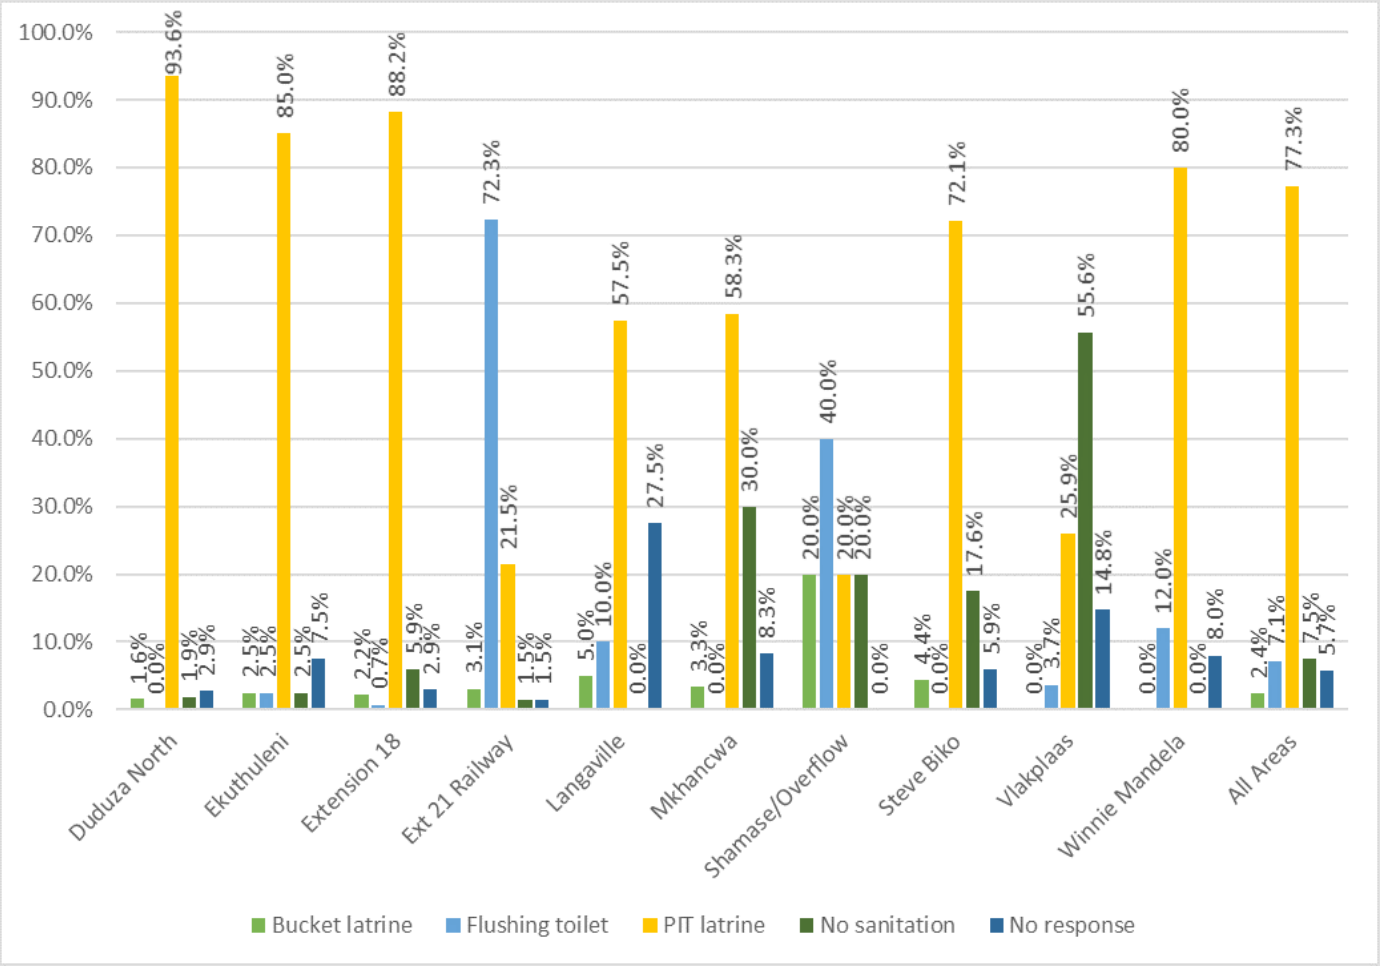
Figure 1A: What type of toilet (if not a portable toilet) do you use?

a PIT latrine. Again, the type of sanitation these residents have access to varies quite significantly across settlements. In Duduza North, Ekuthuleni, Extension 18 and Winnie Mandela, 80% or more of those not using portable toilets indicated that they use a PIT latrine. In contrast, 72.3% of respondents living in Extension 21 Railway indicated that they use a flushing toilet. The latter percentage however corresponds to only 47 of the 127 residents of this settlement who completed a questionnaire. While 40% of respondents in Shamase/Overflow answered that they use a flushing toilet instead of a portable toilet, this share only corresponds to two residents. Almost 56% of residents in Vlakplaas who do not use a portable toilet said that they do not have access to any sanitation. It should be noted though that this corresponds to only 15 of the 346 residents in this area.
