KAMEELDRIFT SOCIAL AUDIT REPORT ON SANITATION

Report on the Findings of the Kameeldrift 298 Social Audit

December 2019

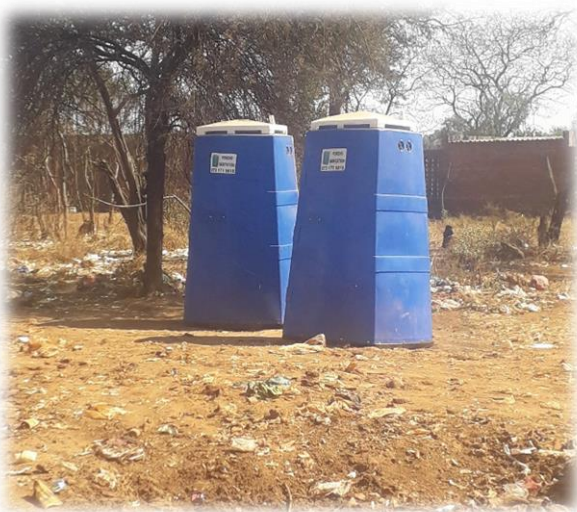
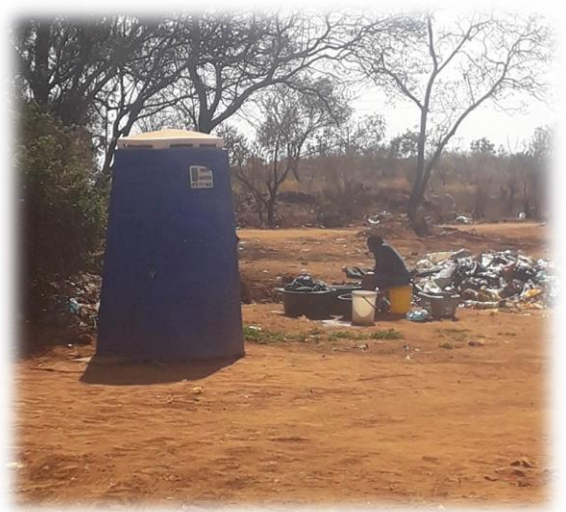
All respondents indicated that disabled people are not able to use the chemical toilets. The physical verification of the chemical toilets confirmed that they cannot accommodate people who are wheelchair bound.

Some of the toilets located in the streets

4.4 Provide wheelchair accessible toilets

The number of wheelchair-bound residents in the settlement varies as people move in and out of the area, but there are currently no sanitation facilities in Kameeldrift 298 that can be accessed by people in wheelchairs.

In this regard, we recommend that the metro provides suitable toilets to the community and also provides specifications for these to the service providers. The table below gives an example of this, taken from the tender specifications for the provision of chemical toilets issued by the City of Ekurhuleni (A-WS 03-2019).⁴

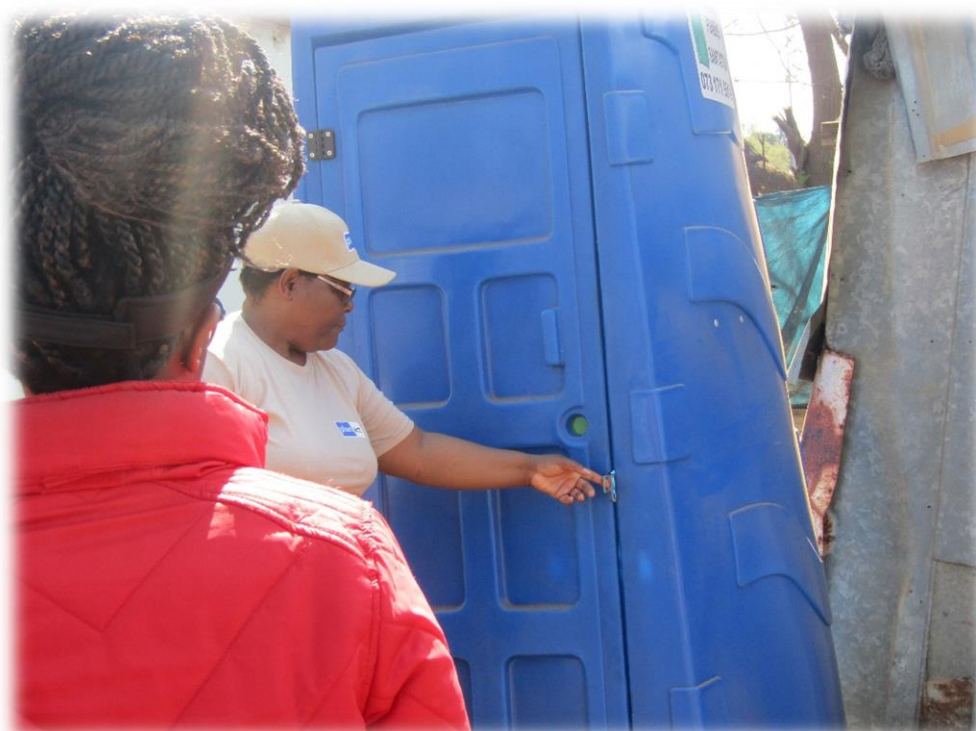
Physical verification of the toilets being conducted

During the physical verification of the toilets, the social audit volunteers found that there are no toilet identification numbers on the units. Not being able to identify a specific toilet makes it very difficult for residents to report any damages to a toilet. It also makes it difficult to report when certain toilets are not being deslugged or cleaned.

In addition, no telephone number (either for the service provider or for the City of Tshwane) was visible on any of the toilet units. Again, this makes it very difficult for residents to report any problems with the toilets or the service. The community members did indicate that the telephone number of the service provider is displayed on the vacuum truck and that the number has worked when they called it. However, this means that residents have to save the number somewhere or wait for the truck to arrive to report any problems with the toilets.

provision for improved identification (e.g. numbering) of toilets, to make it easier to identify and report toilets that are damaged or not being serviced regularly;

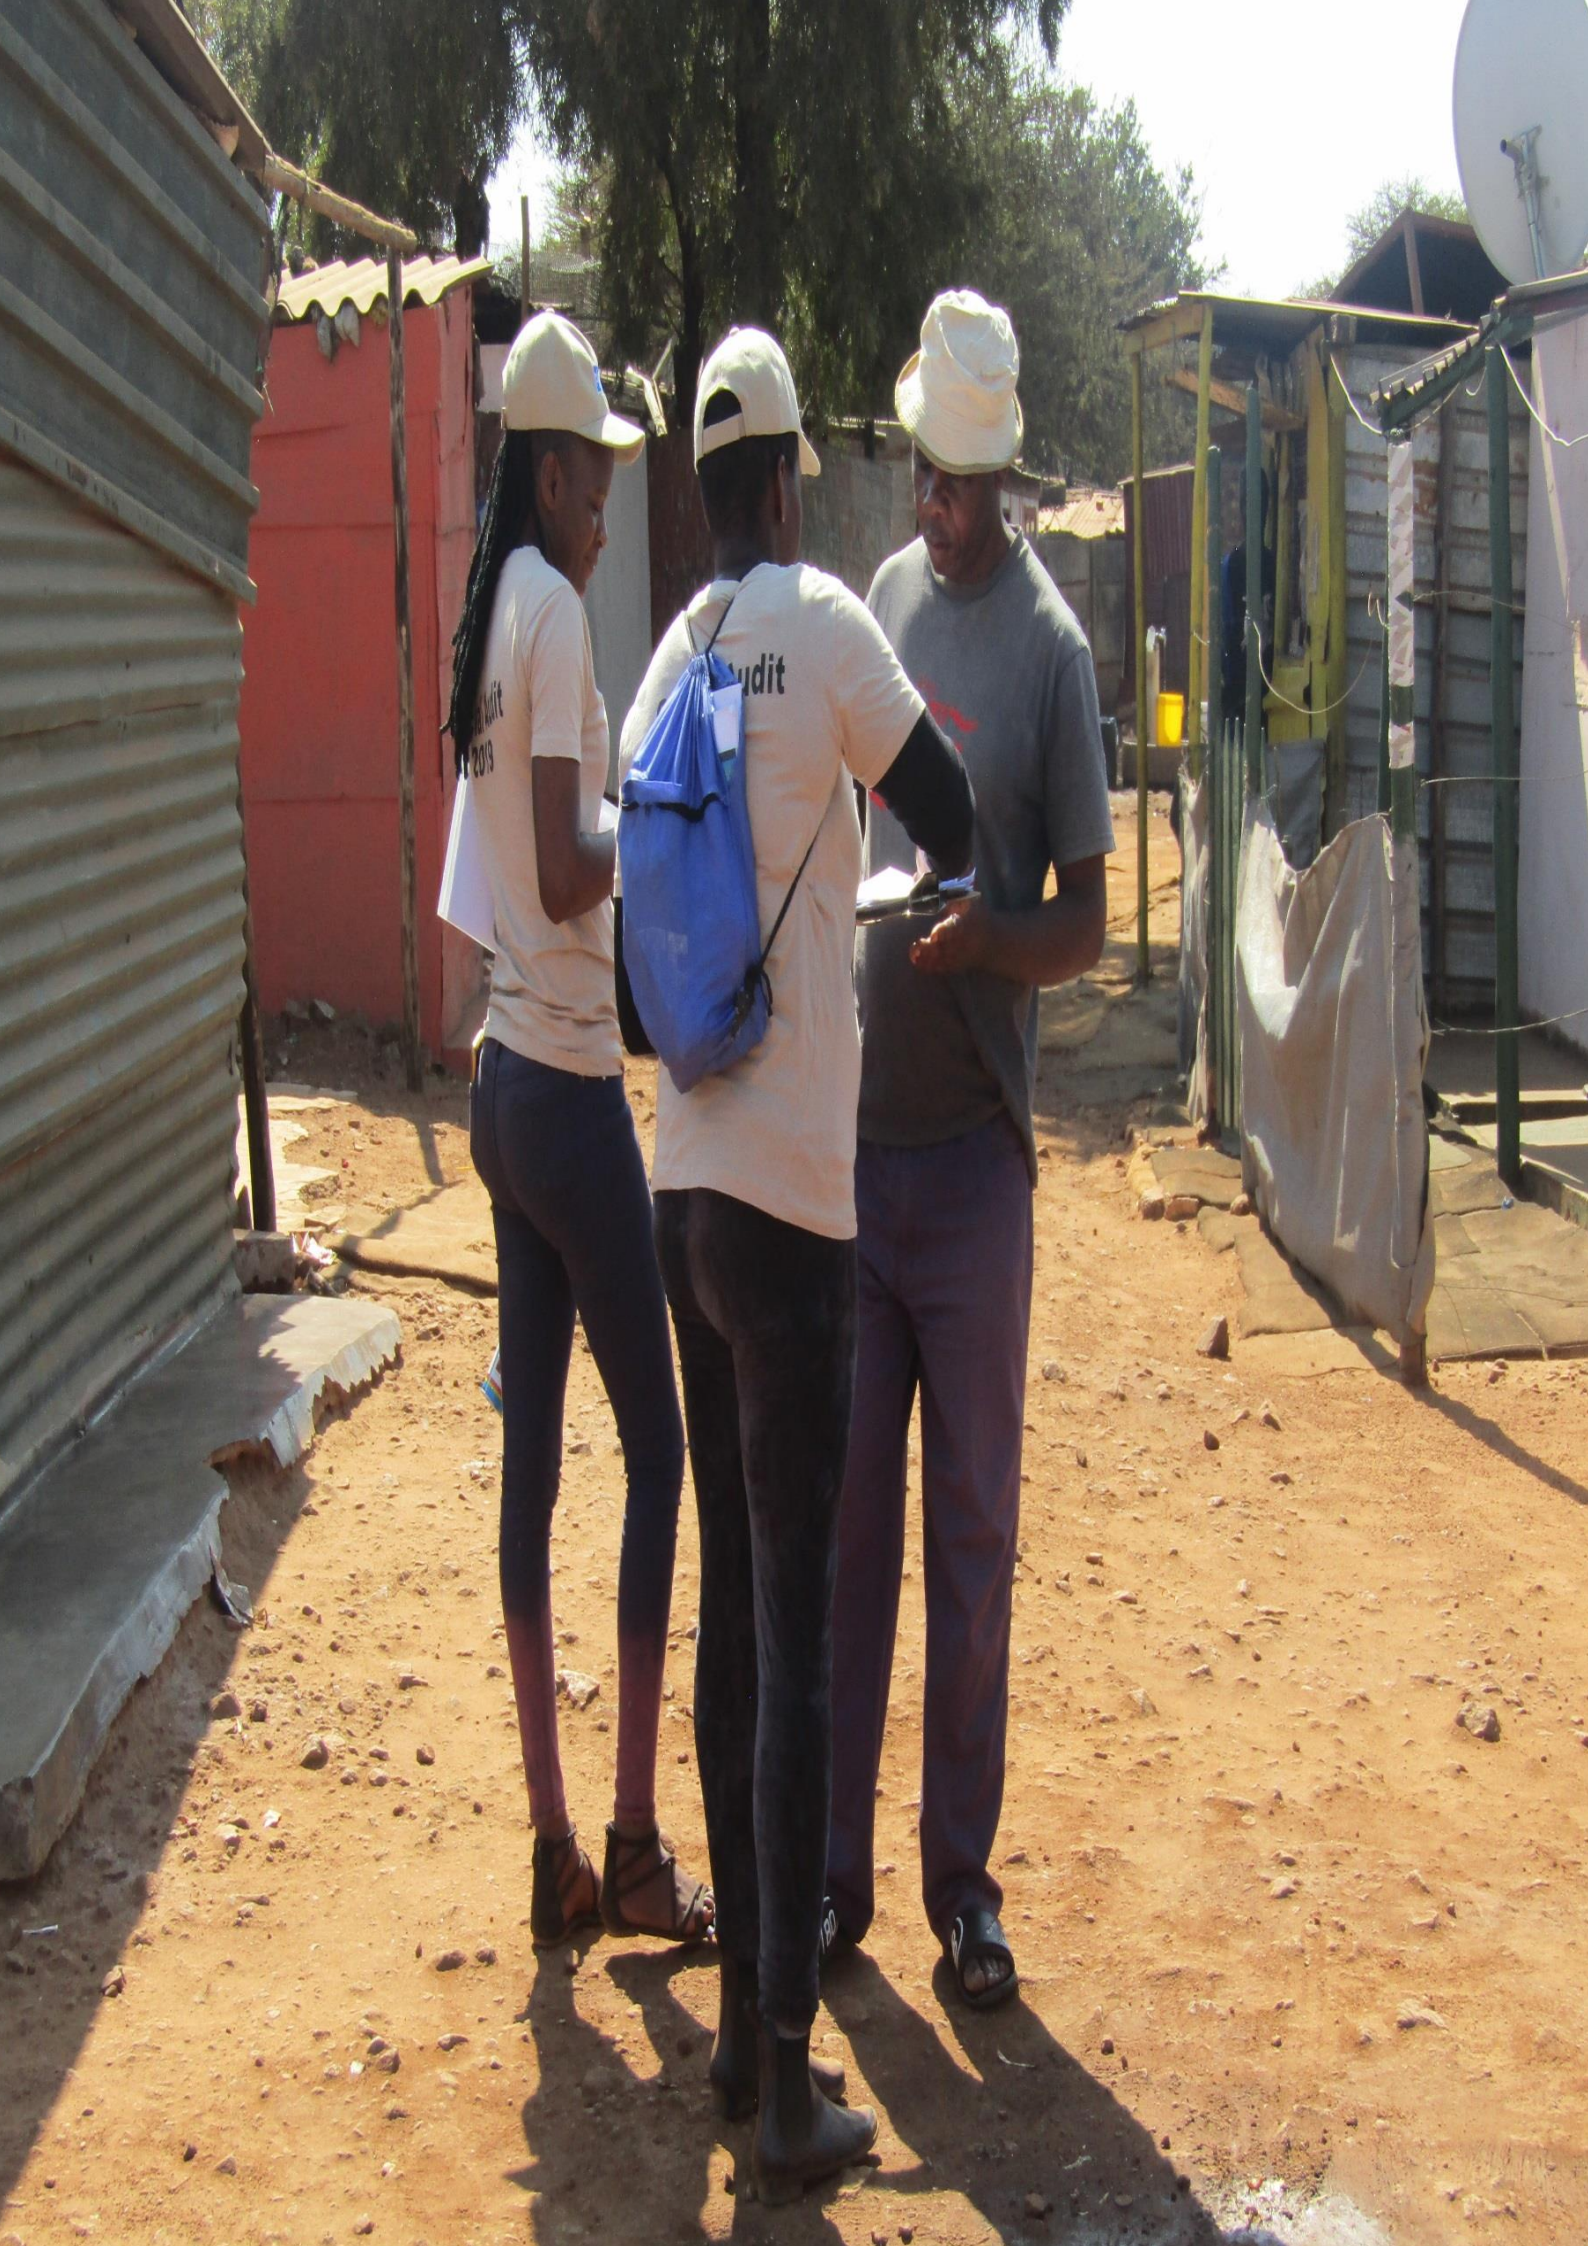
The physical verification of the chemical toilets found that most of the toilet structures are not stable and secure, and the structures do not have steel frames. The instability of the structures might be another reason why residents do not feel safe using the toilets.

In addition, the physical inspection of the toilets found that the seats of the chemical toilets are too big for young children. There are a number of creches in the settlement, as well as an orphanage. The managers of these facilities said that the size of the seats was a major problem, especially as children do not often ask for assistance when they want to use the toilet.

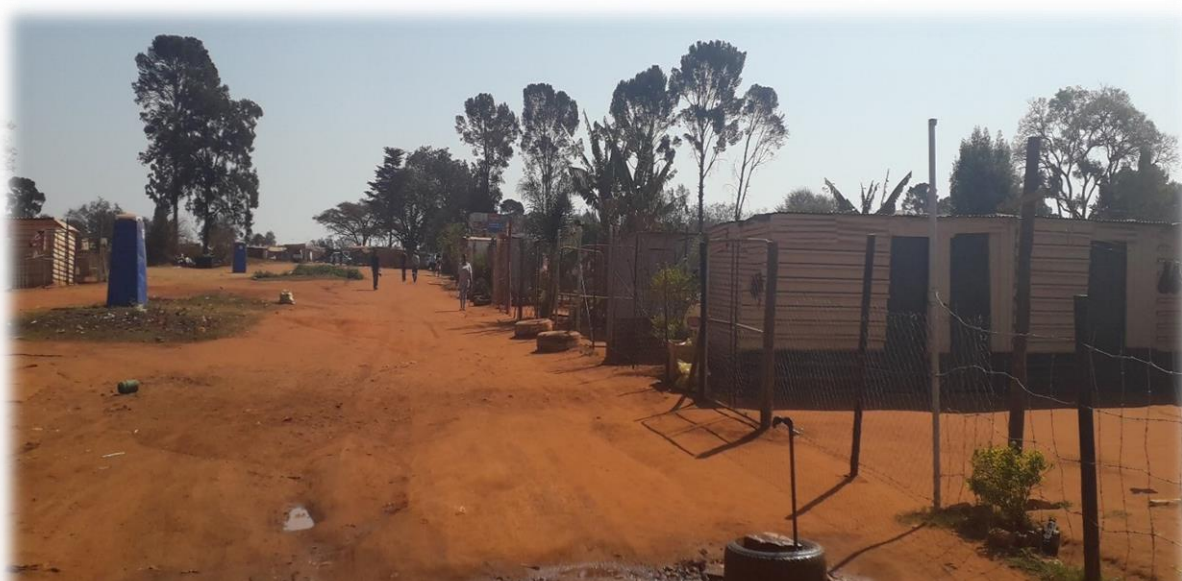
As indicated in Figure 3 below, 68.1 percent of residents interviewed said that they do not feel safe using the toilets. The community mentioned the lack of street lights as one of the factors contributing to the lack of safety they experience. The social audit volunteers also noted that there are not enough street lights in the area. The lack of adequate street lighting makes it especially dangerous to use the chemical toilets at night.

Toilets situated in the streets that do not have street lights

more specific requirements to ensure that the toilets are stable (e.g. requiring toilets to have a steel frame);

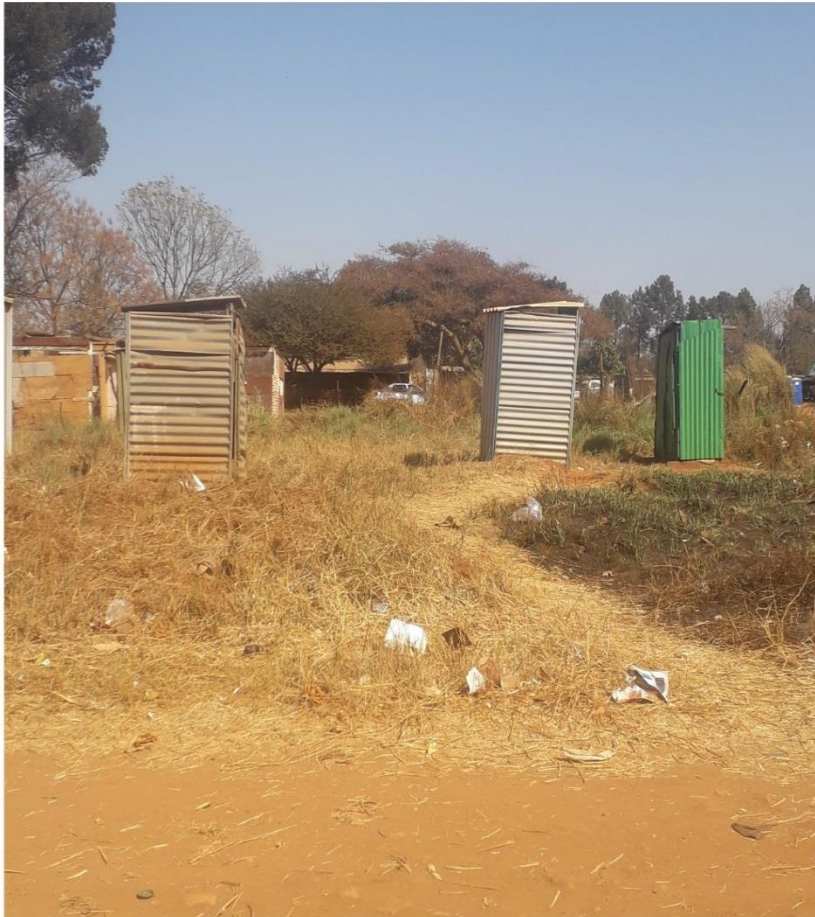
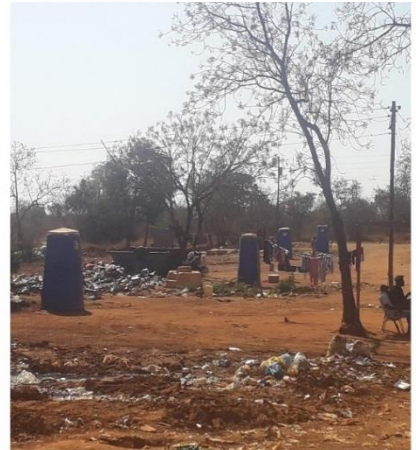
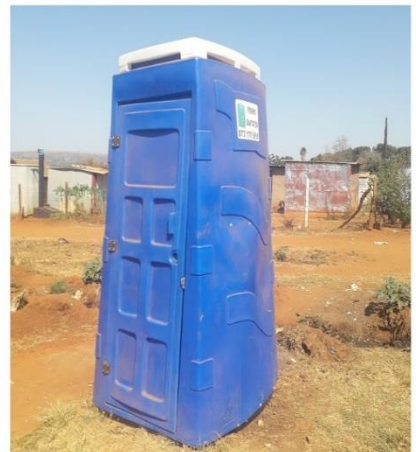
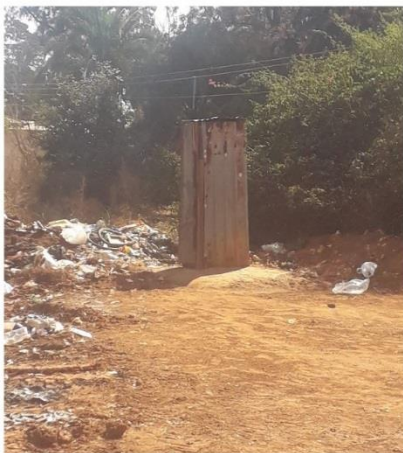
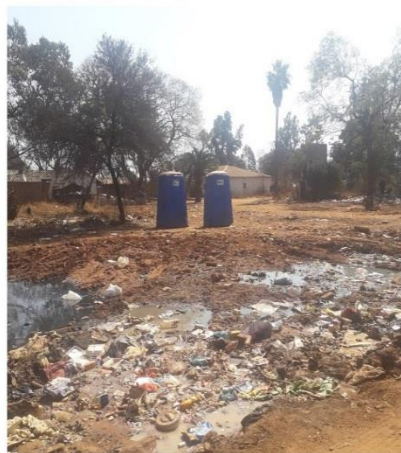
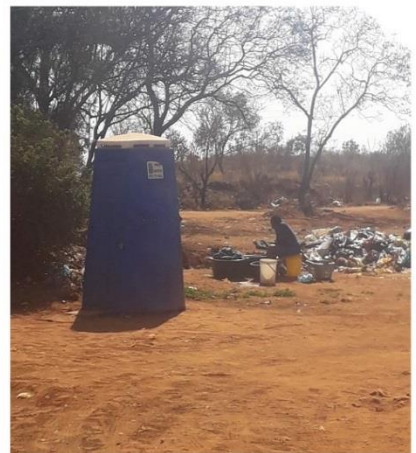
Conditions of toilets in kameeldrift

more detailed guidelines on how the toilets should be cleaned (including the various parts of the toilet unit and the timing of the cleaning immediately after the removal of the human waste);

more specific requirements for the installation of extraction pipes and vents to improve ventilation inside the toilets;

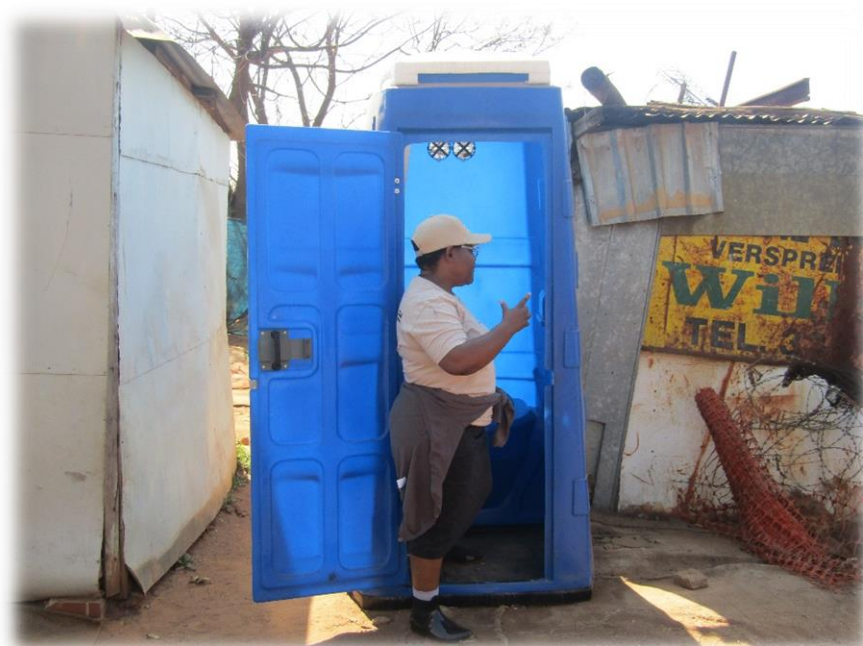
Shumani Luruli, using one of the toilets to explain and elaborate the bid specification tender document
