**LAWLEY STATION
INFORMAL SETTLEMENT
SOCIAL AUDIT REPORT
ON SANITATION
NOVEMBER 2019**

Findings from the Sanitation Needs Assessment in Lawley Station Informal Settlement

November 2019

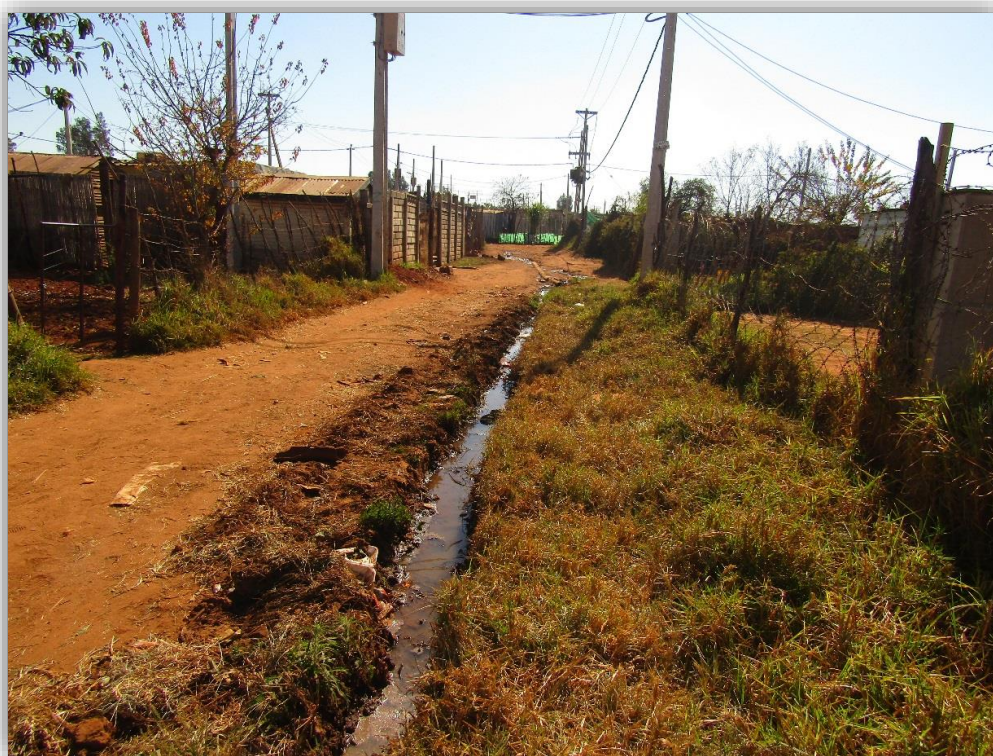
Sewage of another settlement passing through the street of Lawley station

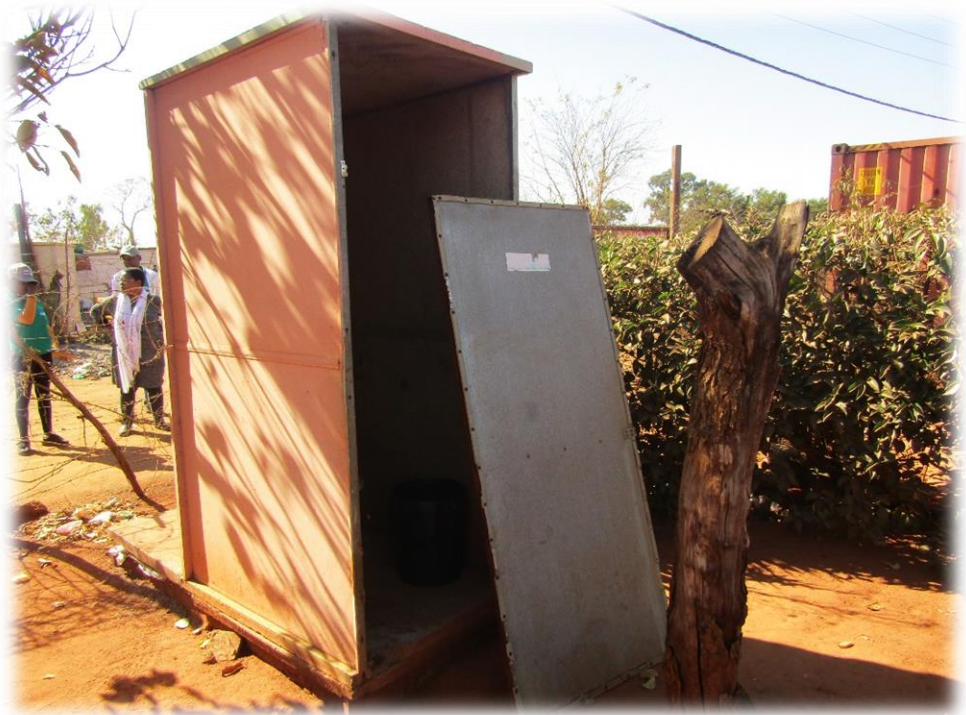
One of the toilets with a broken door in lawley station informal settlement.

- As a priority JW should attend to:
 - a) Major repairs:
 - Improve the stability of 599 unstable toilet structures
 - Repair/provide ventilation pipes for 492 toilets
 - Repair/provide cement slabs for 428 toilets
 - Repair/provide doors for 658 toilets
 - Repair/provide toilet bowls (boxes over pit) for 411 toilets
 - Repair/provide walls for 281 toilets
 - Repair/provide roofs to 185 toilets
 - b) Minor repairs:
 - Repair/provide toilet seats for 263 toilets
 - Repair/provide lids for seats for 457 toilets
 - Repair/provide locks for 502 toilets
 - c) In case where extensive major repairs are required, JW should provide a completely new super structure (i.e. toilet unit, including the door, and the floor slab)

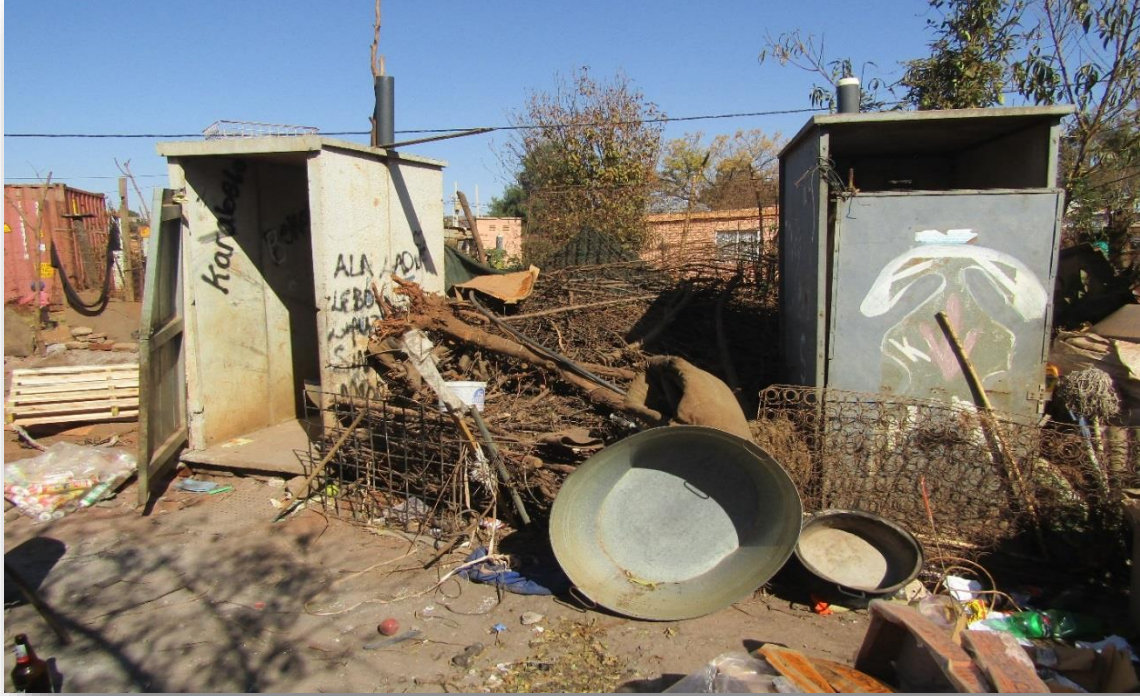
Lawley Station). Finally, there are 373 stands in Thembelihle and 46 stands in Lawley Station without *Some of the toilets which are full and cannot be used in Lawley Station* a VIP toilet.

- While some residents have received new VIP toilets, the state of some of the pits of the older VIP toilets in Lawley Station is a major issue affecting the desludging of these toilets. Due to the age of the pits, the waste at the bottom of the pit has begun to harden and cannot not be removed. The result is that the pits are consistently close to full, and this impacts on the regularity with which these toilets need to be desludged. It is recommended that JW does a full assessment of all pits in Lawley Station, and either rehabilitates aging pits or replaces their sub-structure i.e. excavate a new pit and lay a new foundation.

- JW should, in consultation with the community of Lawley Station and in consideration of the other recommendations listed in this report, review the desludging schedule for Lawley Station to ensure that desludging is done on a regular basis and often enough to ensure that no toilets are overflowing. The evidence collected during the needs assessment suggests that there is currently no consistency in how often the toilets on different stands are being desludged.

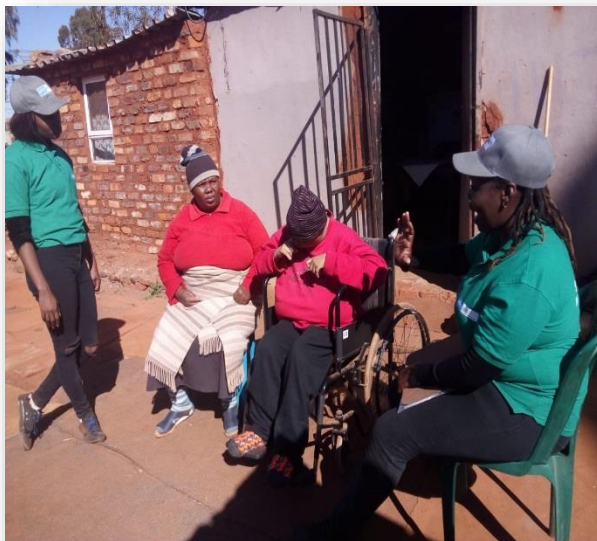
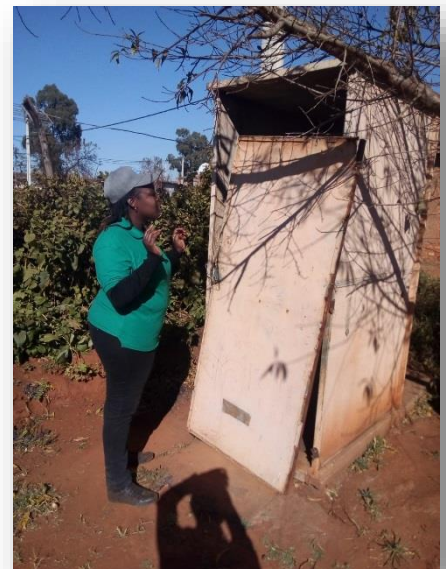
Currently there are 19 people living with physical disabilities which prevent them from using the JW VIP toilets in Lawley Station. This, for example, includes people in wheelchairs who are not able to use a VIP toilet. This means that they have no access to sanitation in the settlement. The names and contact details for these residents, as well as stand number where available, have been recorded.

A disabled person on the left is expected to use the JW VIP toilet on the right

- JW should provide one disabled friendly toilet for each of the 19 disabled residents that have been identified as living in Lawley Station.
- In addition, we recommend that JW puts in place a clear and simple process that a resident can follow to request an additional toilet suitable for a disabled person, when the need arises.

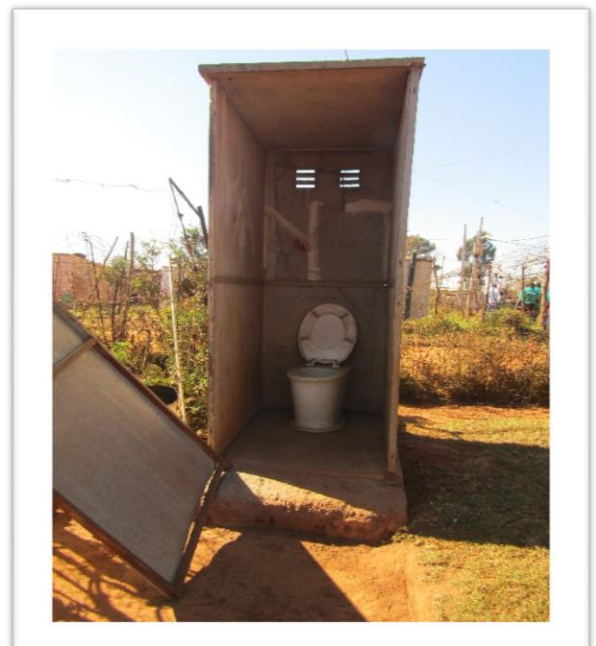
The main major issue identified during the physical assessment of the JW VIP toilets is that the doors of 615 or 54.9 percent of toilets are damaged. A further 43 or 3.8 percent do not have a door at all. With an average number of households of 2.44 per stand in Lawley Station, this means that potentially just more than 1 500 households use a structure with a broken door, and a further 105 use a toilet with no door at all. (As discussed earlier, for most of the 24 stands with more than one VIP toilet, only one toilet was assessed. This means we only have information for one toilet per stand. For the sake of simplicity, we use the number of households

One of the damaged toilet door in Lawley Station

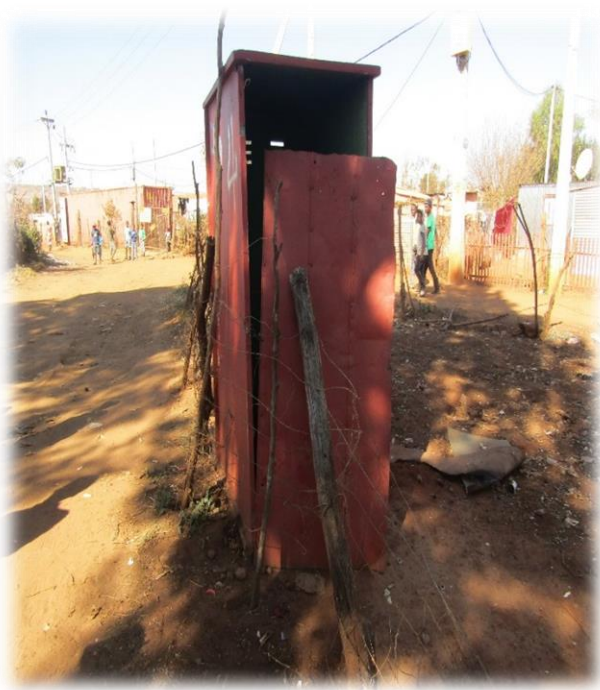
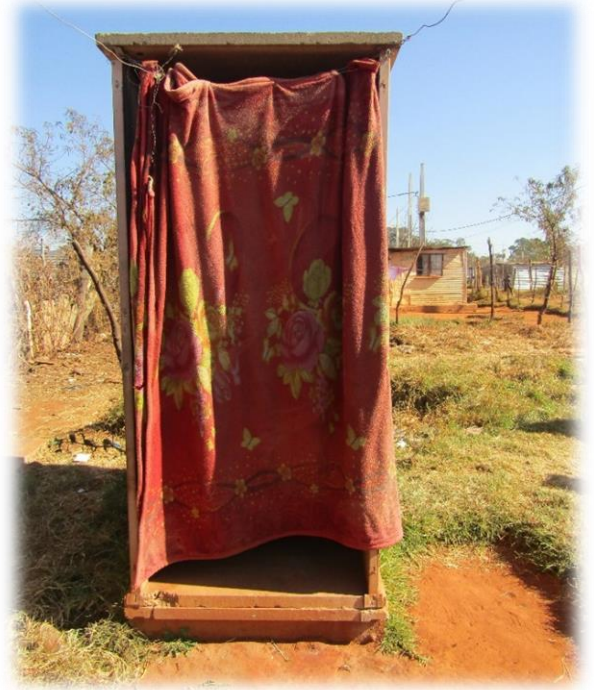
Current state of toilets in Lawley Station

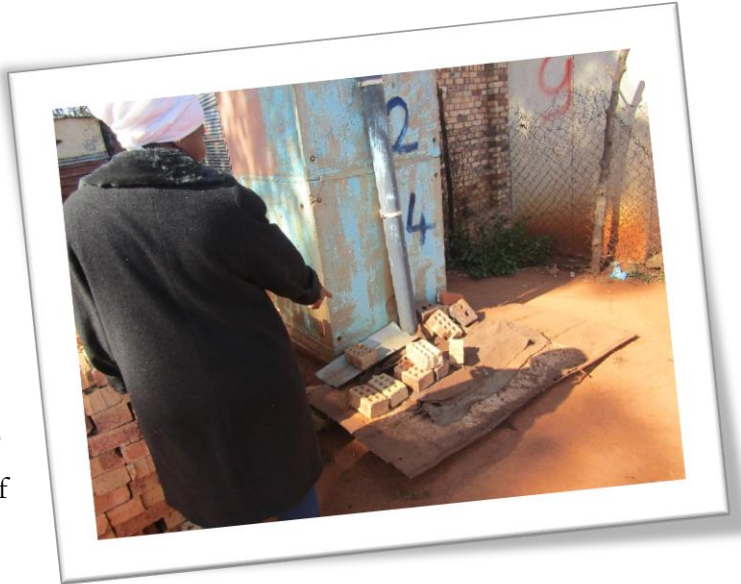
One of the most common challenges raised relates to ***lack of safety***. Of the 1120 respondents with a VIP toilet on their stand 74 percent or 827 indicated that they do not feel safe when they use the toilet. Of these, 328 respondents said they do not feel safe as a result of the damages to and the instability of the toilet structure and 35 respondents specifically mentioned the lack of privacy as a result of the broken doors.

Toilet barricaded with Zinc Iron and bricks where a 2-3 years old child feel into

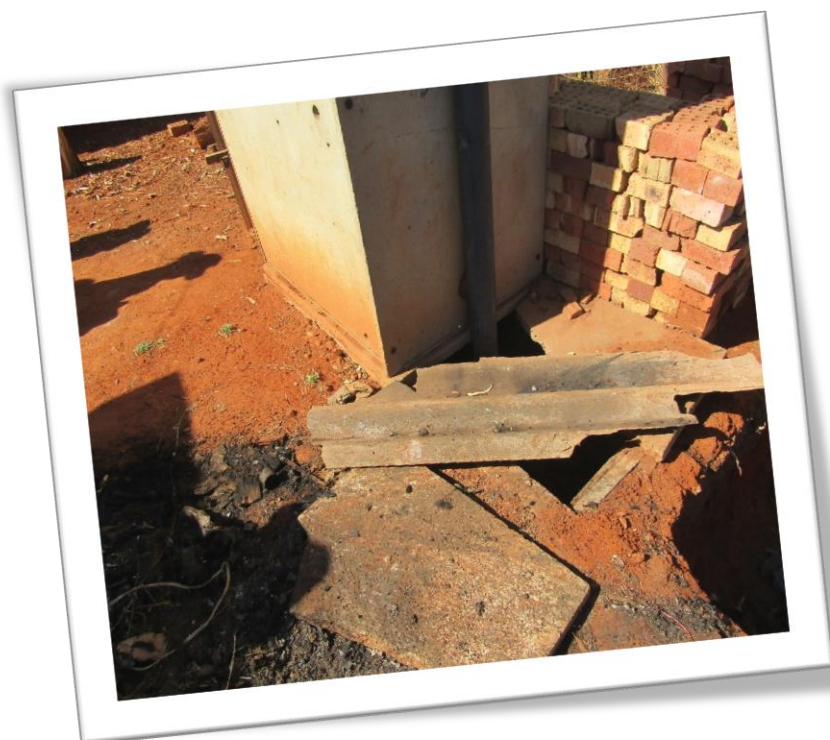
The **bad smell** inside the structures was repeatedly raised as a major problem – 366 respondents identified it as a challenge that they face because of the VIP toilets, while 291 respondents mentioned it as a reason for their lack of satisfaction with the service. Residents also mentioned that they experience health problems as a result of the bad smell.

One of the toilets in Lawley with a broken slab which emanate bad odor
