# WATTVILLE SOCIAL AUDIT REPORT

The social audit investigated the tender on **"hiring, delivery and maintenance of chemical toilets"** in Ekurhuleni Metropolitan Municipality.

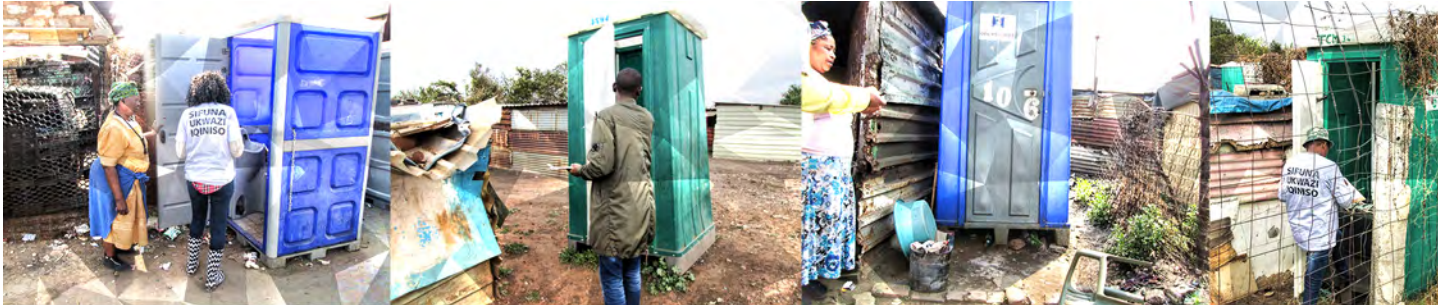
On inspection, is the toilet safe and secure?

During physical verification, 59.5% of toilets were found to be safe and secure, but 37.9% of toilets were found not to be safe and secure. The remaining 2.6% were not inspected for this question. The top three reasons given for why they were not safe and secure are represented by the following quotes:

- Unstable - “It is unstable”, “it is not well placed”, “It is placed on top of bricks”, “it shakes when you enter”, “it is tilted to the side”, “and there are planks under it”.

- Unsafe location - “It is under a bridge”, “it is on the road”, “it is next to the street”
- Doesn't lock - “the door is not lockable inside and out”
- In terms of stability, the bid document specifies that toilets should be supported with a steel frame built inside for rigidity. 84% of the toilets did not have a steel frame built inside for rigidity, only 8.6% did, and 7.4% could were not inspected for a steel frame.
